ANNEX I

2nd report on SEED project (Identification of landslide phenomena and landslides prone areas into the CKNP and in its buffer zone)

Dr. Chiara Calligaris, Prof. Giorgio Poretti, Dr. Shahina Tariq and Mr. Hawas Khan

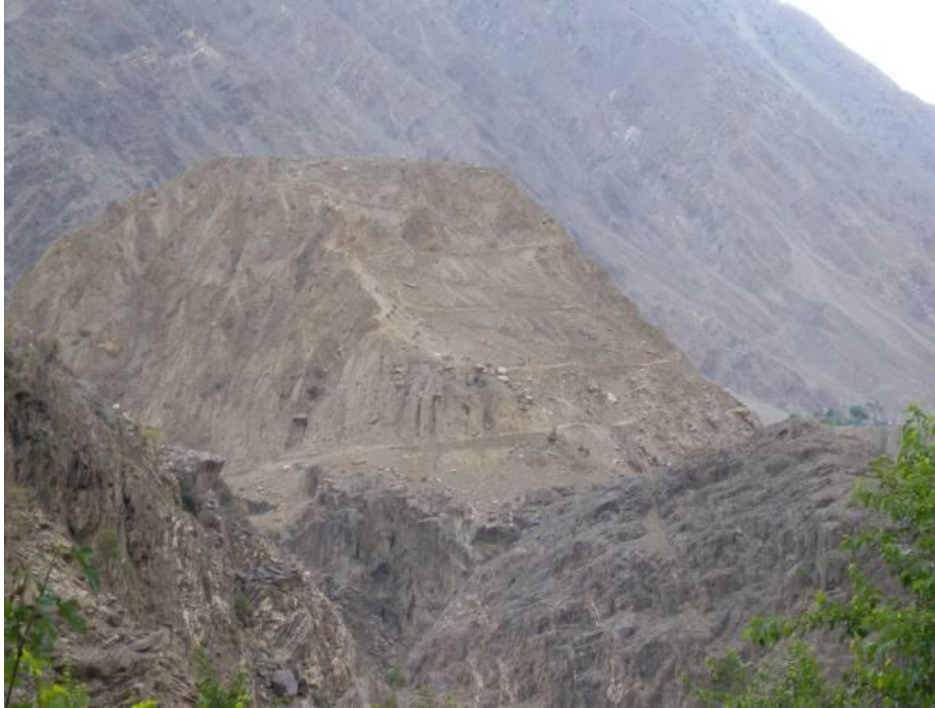
Figure 1: Road to Khaltaro and Dasso villages built on alluvial terrace. The instability is very high as the danger while running this road.

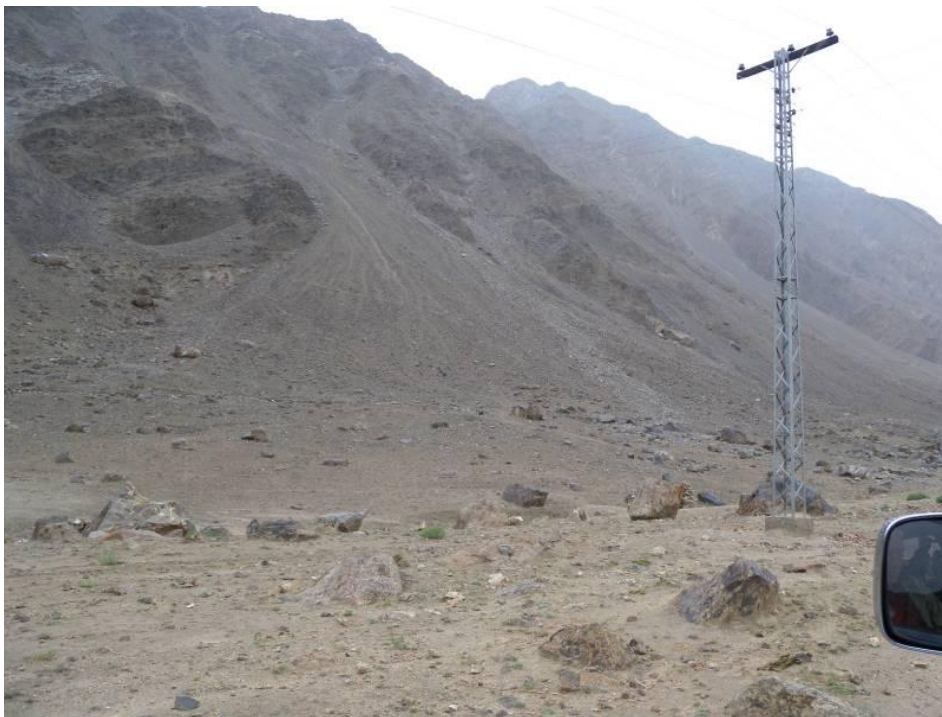
Figure 2: Detrital fan upstream a small village located before the intersection to Muruk.

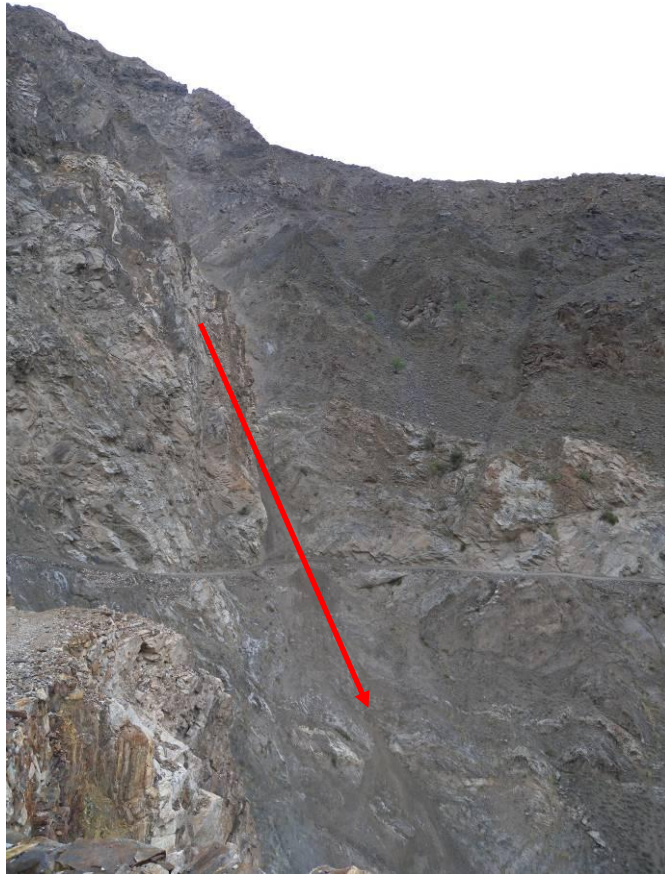
Figure 3: Debris flow on the way to Khaltaro. Its return time is several times a year, depending on the rainfall. Red arrow is indicating the movement direction.

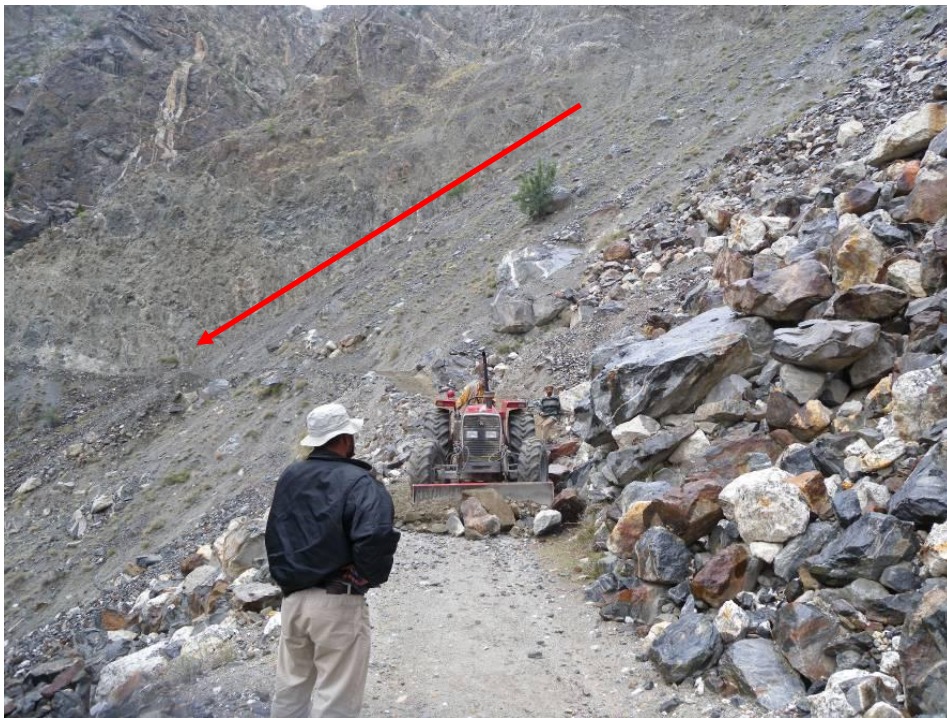
Figure 4: “Fresh” landslide on the way to Khaltaro. Repeated rock falls created a wide heterogeneous fan. The grain size of the boulders and clasts is clearly visible. Also in this position, as for the described debris flow, the return time is several times a year. Red arrow indicate the movement direction and the slope angle (about 45°).

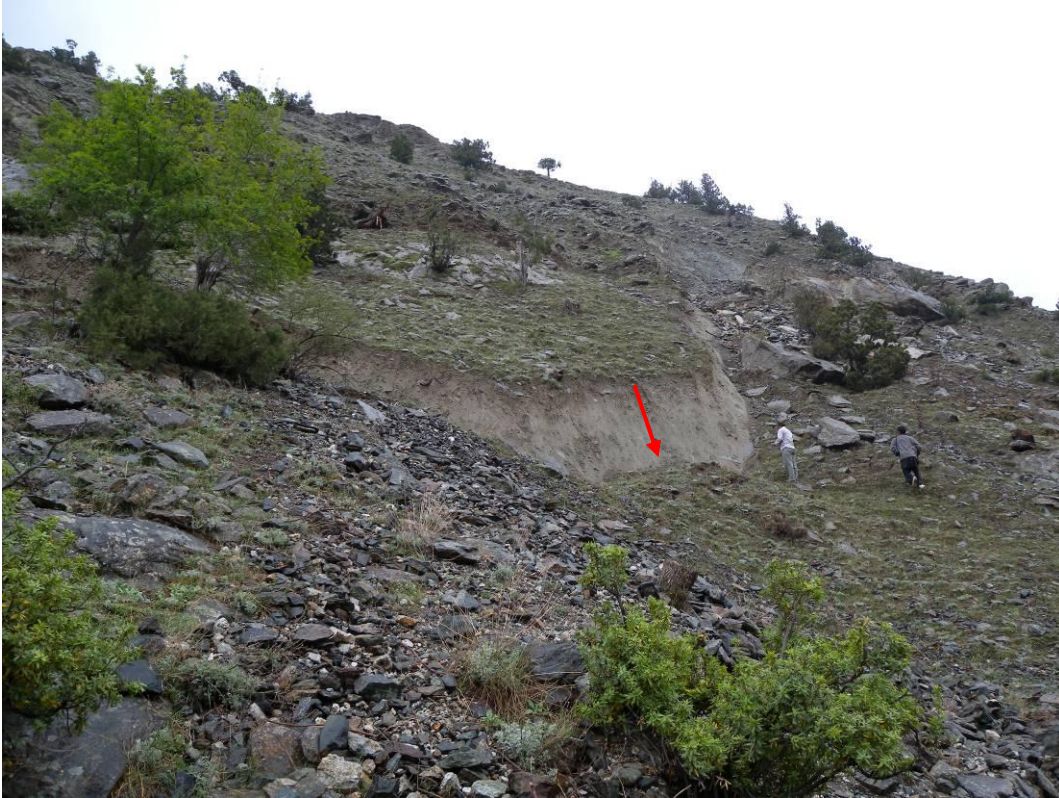
Figure 5: Khaltaro landslide, the main scarp is clearly visible; its high is approximately 4m.

Khaltaro landslide is a sliding movement of detrital material over a rocky surface. The length of the crown is approximately 200m, the high of the main scarp is about 4 m (Figure 5 and 6), all around the crown there are tension cracks 1,5m wide (Figure 7). Walking on the main body, is possible to identify several longitudinal tension cracks with a gap of 10 to 15cm. This landslide is particular because, at the toe of the slope, on the right side of the river, there is the village with houses and fields. The phenomenon is directly insisting on the settlement. Witnesses told that the movement begun one year ago. Now the Pakistani government located some tents in a safer place (Figure 8), close to the village in order to avoid the worst.

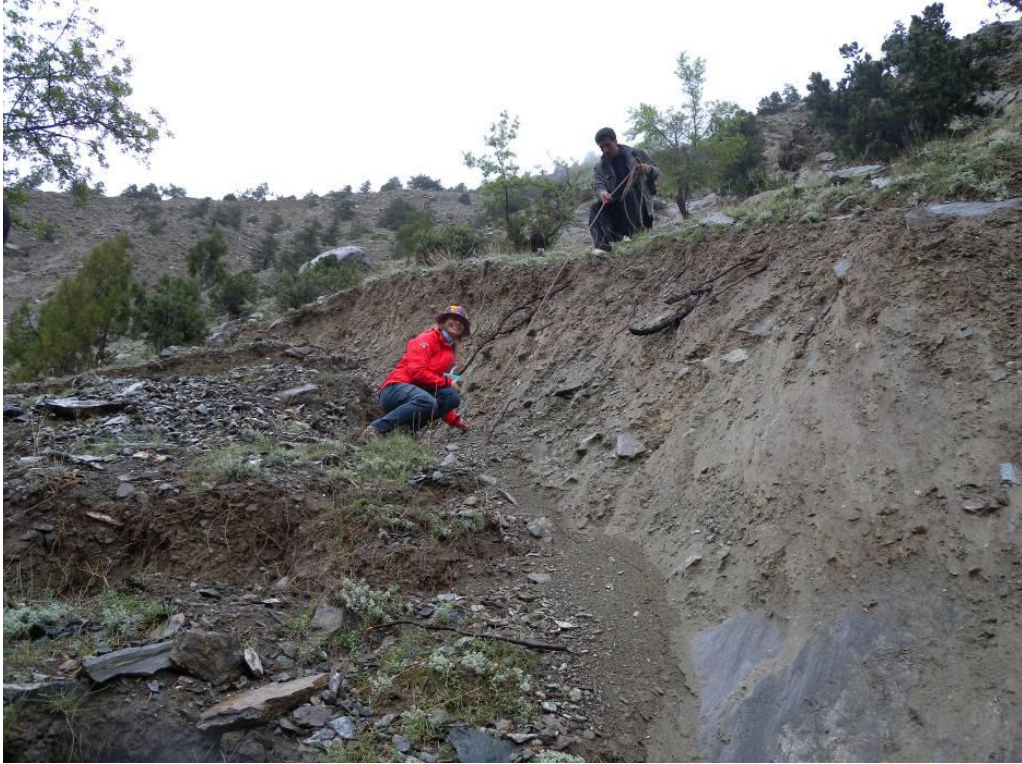
Figure 6: A monitoring moment: measuring the main scarp with a rope. The debris material is sliding over a sloping strata angle as the slope.

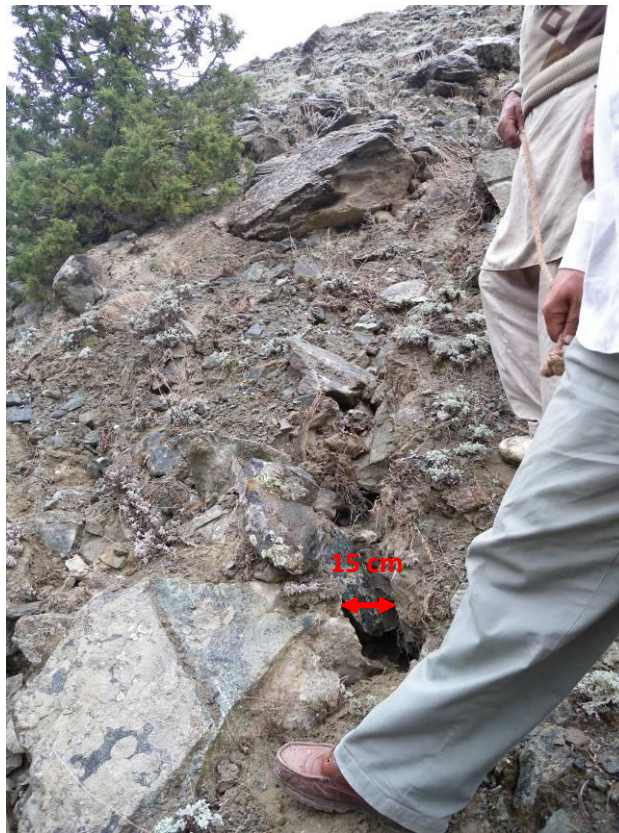
Figure 7: Tension crack on the right side of the landslide with a gap of 15cm.

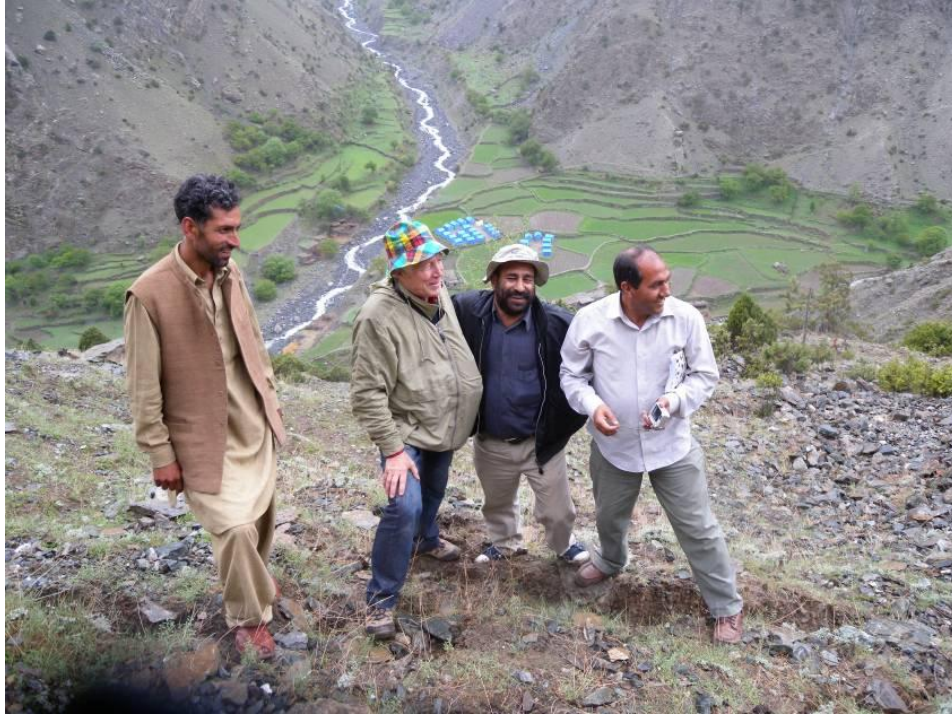
Figure 8: Researchers on the main body of the landslide. On the background is possible to see the blue tents belonging to the Civil Defence.

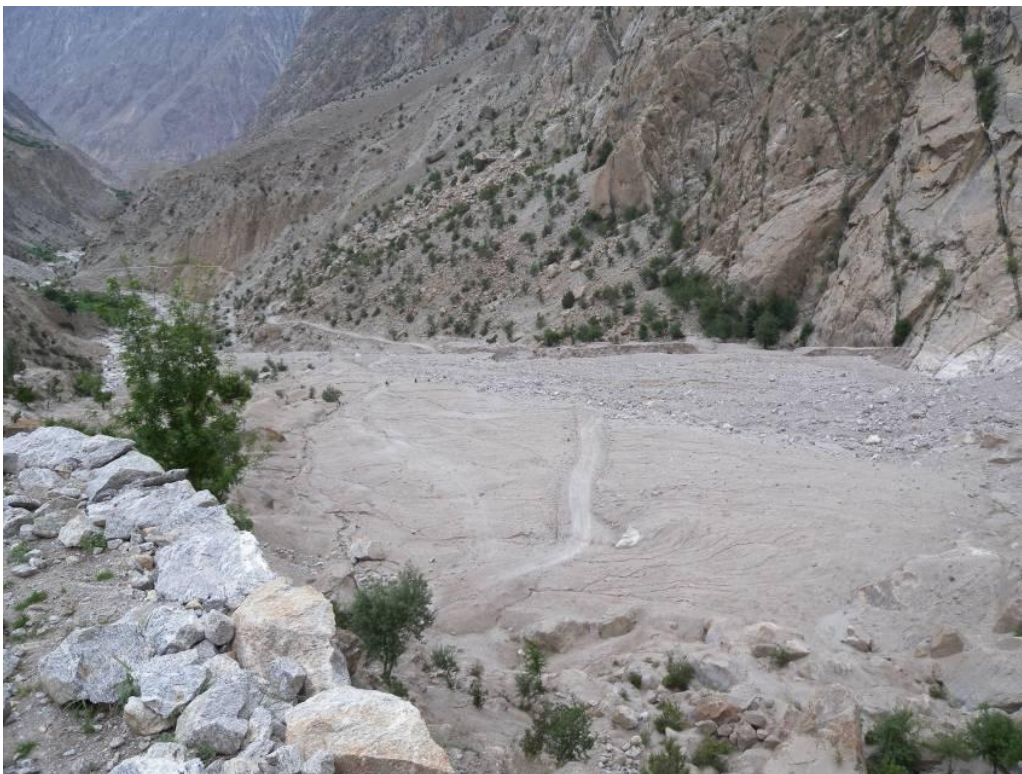
Mani glacial valley is an East-West oriented valley. To reach it is necessary to pass through Dasso village and to Barche. Going after Barche, to the Way to Gure, is possible to come across a debris flow phenomenon that invested the main road and all the cultivated fields present in the valley (Figure 9).

Figure 9: Debris flow deposits that covered all the cultivated fields. The photo is realized from the upper point of the fan.

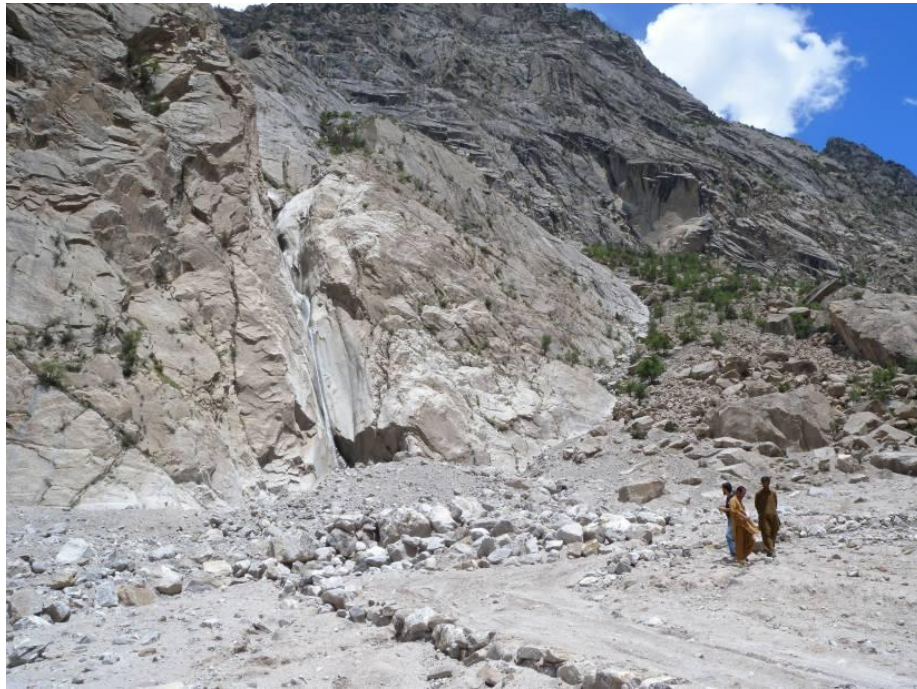
Figure 10: Upper side of the alluvial debris flow fan.

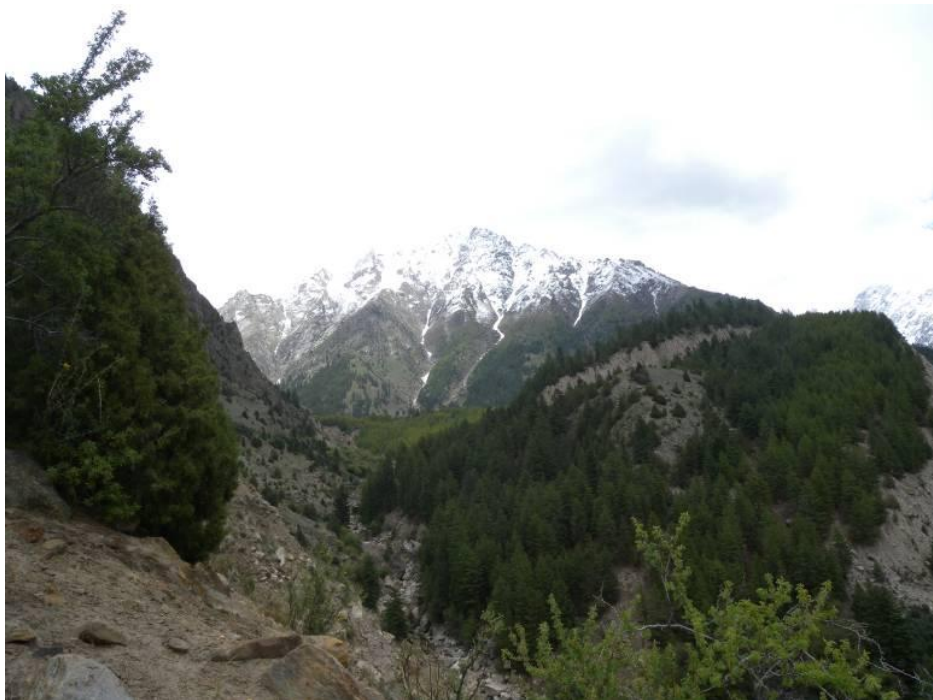
Going on from Gure to the internal side of the glacial valley, an alpine valley is present on the way to Baskari glacier. Here landslide phenomena are rare due to the intense vegetation present in the area. Himalayan fir are all over and grass and bushes cover the slopes (Figure 11). On the Mani Glaciar valley instead, a u shape valley is present and the glacier eroded the banks giving rise to several landslides (Figure 12).

Figure 11: Baskai Glacier valley: landscape view.

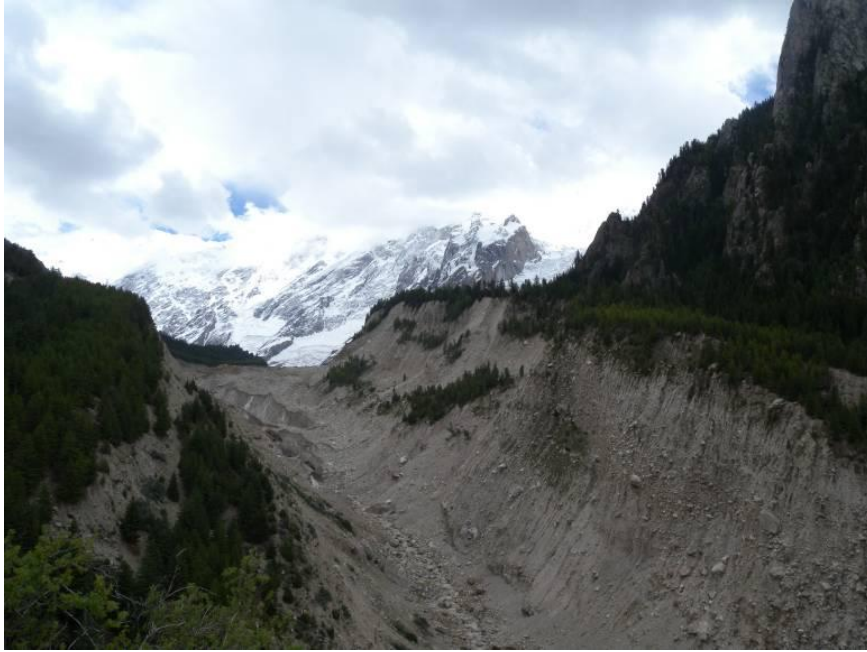
Figure 12: Mani Glacier valley: U shape is evidenced. Several “small” landslides (rock falls and rotational) are occurring along the bank sides of the valley. The activity is highlighted by the trees disposition along the banks.

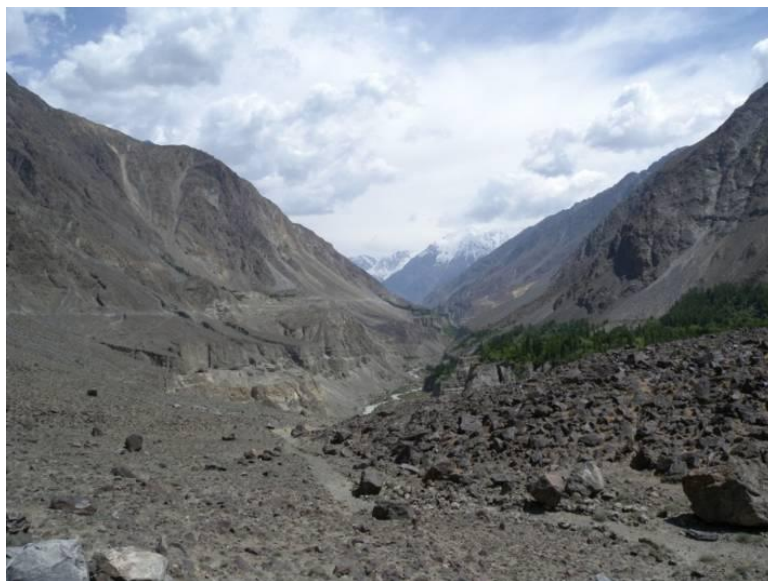
Bagrot valley is a North –South oriented valley in the buffer zone area of the CKNP. From the road located in hydrographic left of the Gilgit river, a jeepable road is going into the valley. This road along all its way until the meeting point with the glacier, is scattered by landslides. Along both sides of the Bagrot valley the slopes are interested by active detrital fans (Figure 14). In several points the road is interested by active landslides that block the road when a paroxysmal event occur. On the way are still visible the traces of an ancient slipped volume that blocked completely the Bagrot Gah river (Figure 13) creating a lake. From the road is possible to see the presence of old lacustrine deposits located over the alluvial terrace.

Figure 13: panoramic view of the Bagrot valley from S to N.

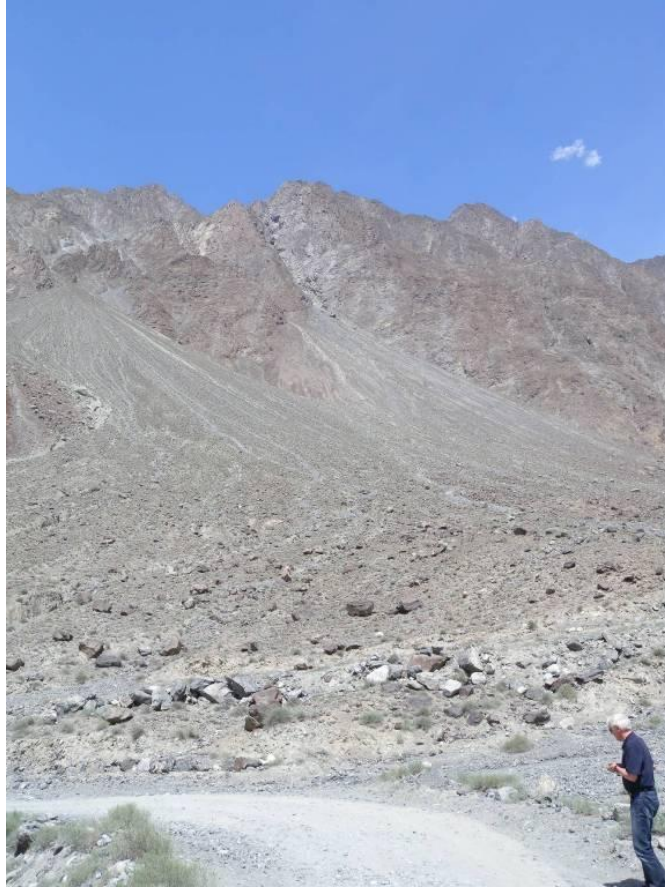
Figure 14: Detritical fans along the road into Bagrot valley.

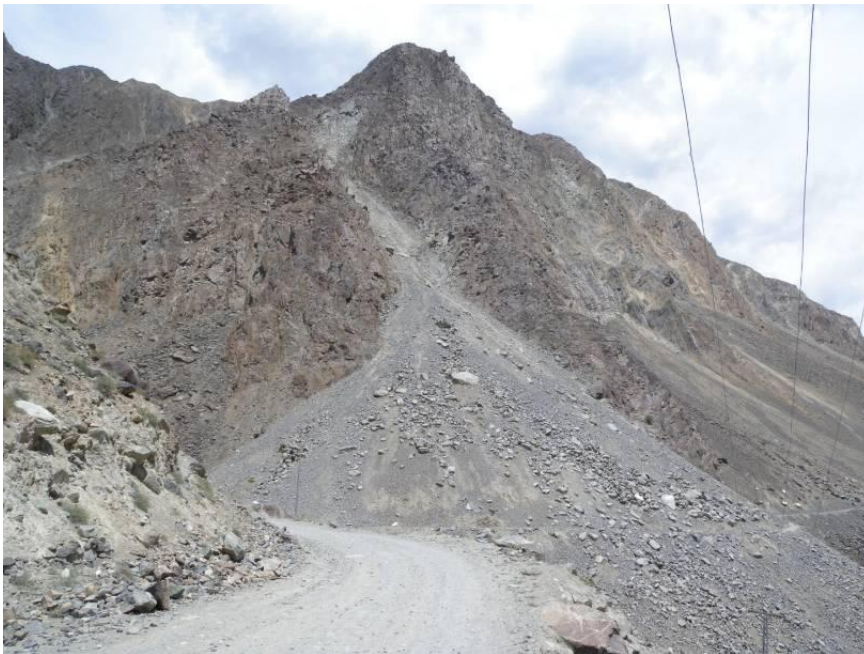
Proceeding from South to North, on the road there is an active landslide (Figure 15) that causes big problems to the passage of vehicles. The phenomenon started with a rock falls and created a fan of heterogeneous material. Half part of the slopes along the whole valley is interested by detritical fan due to rock falls that decrease the slope inclination of the entire valley.

Figure 15: An active landslide on the road to Bagrot valley.

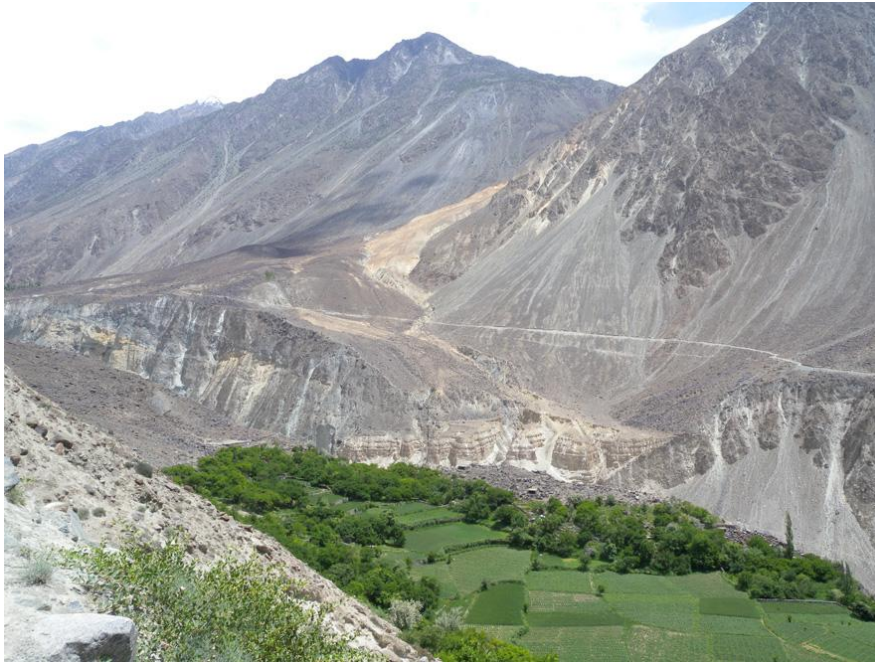
Before arriving in Datuchi village, on the hydrographic side of the valley, there is the presence of a big debris flow deposit. This debris flow is made by really small size material in which there is the presence of gold particles. The Chinese people offered the Pakistani to work on the deposit and to give to the Pakistani the 40% of the founded gold. Pakistani refused the offer.

Figure 16: Golden debris flow.

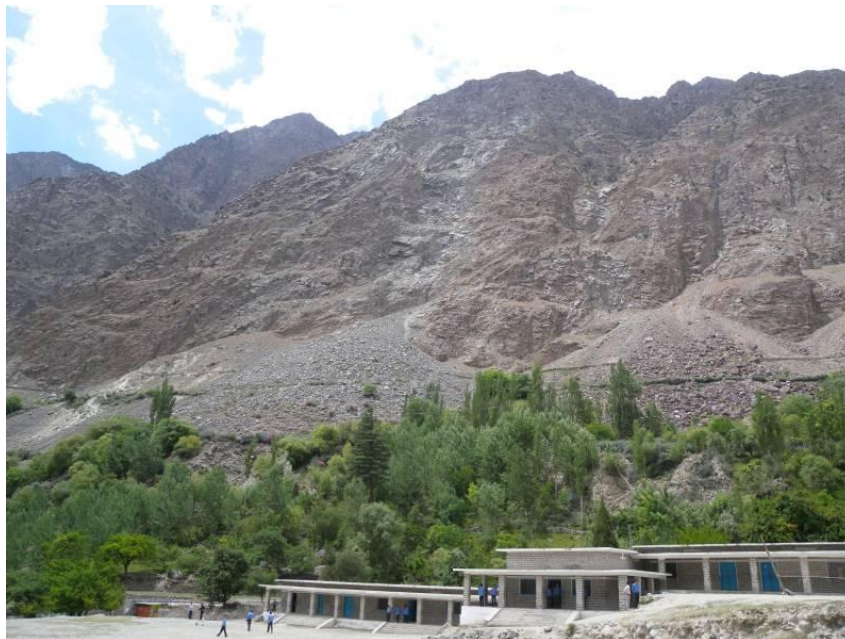
On the slopes over Datuchi village, a long belt of detrital fans is present. These fans are active where there is no vegetation, instead where the water is present and grass, shrubbery, bushes and trees are on site, the slopes can be considered stable (Figure 17).

Figure 17: Scree slopes over Datuchi school.

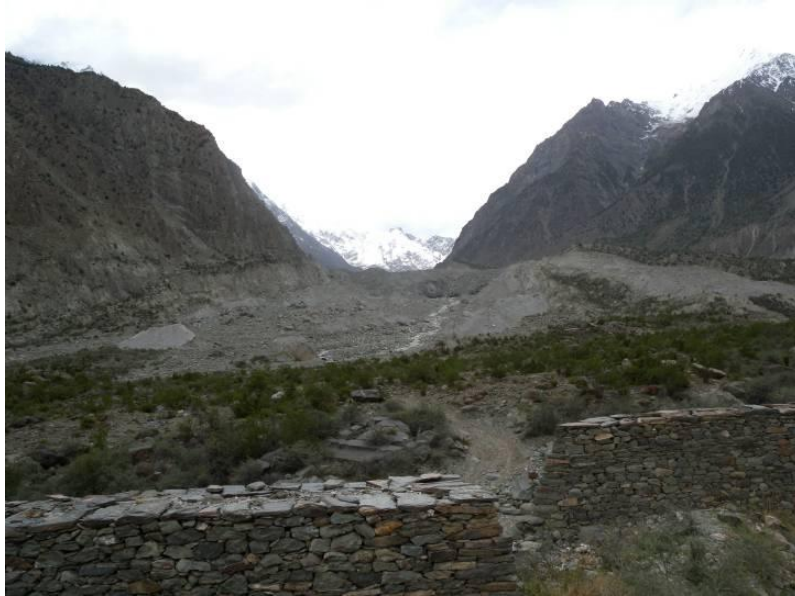
At the end of Bagrot Valley, Hinarche glacier is present at the toe of Diran peak. The valley has a typical U shape given by the glacial erosion (visible also on the image). The slopes of the valley are gentle with a belt of detritical fans at the bottom of the slopes. Frontal and side moraines are present in the valley (Figure 18). Vegetation is quite rare at the elevation of the frontal part of the glacier.

Figure 18: Hinarche glacier, landscape view.

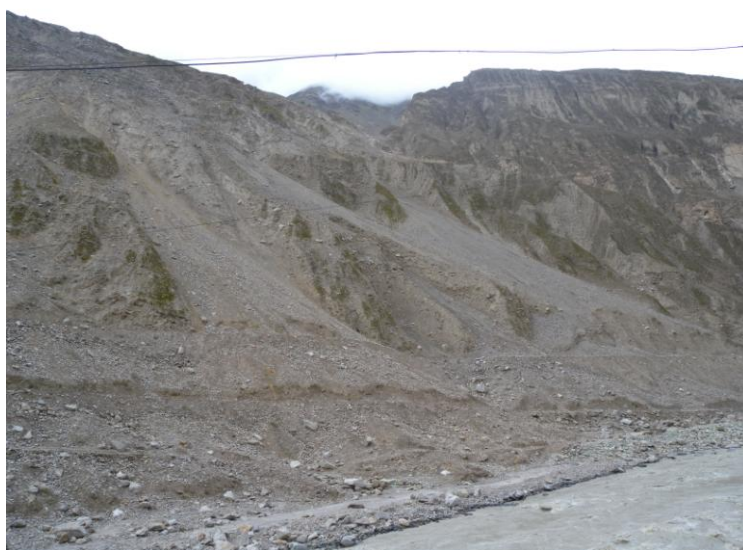
To reach the Hopar Glacier valley it is necessary to pass through the village of Nagar. Access to Nagar is difficult: an old road has been overwhelmed by a landslide forcing the inhabitants to build a new road on the left side of the valley. Several landslides are present (Figure 19, 20).

Figure 19: Detritical fans along the road to Nagar.

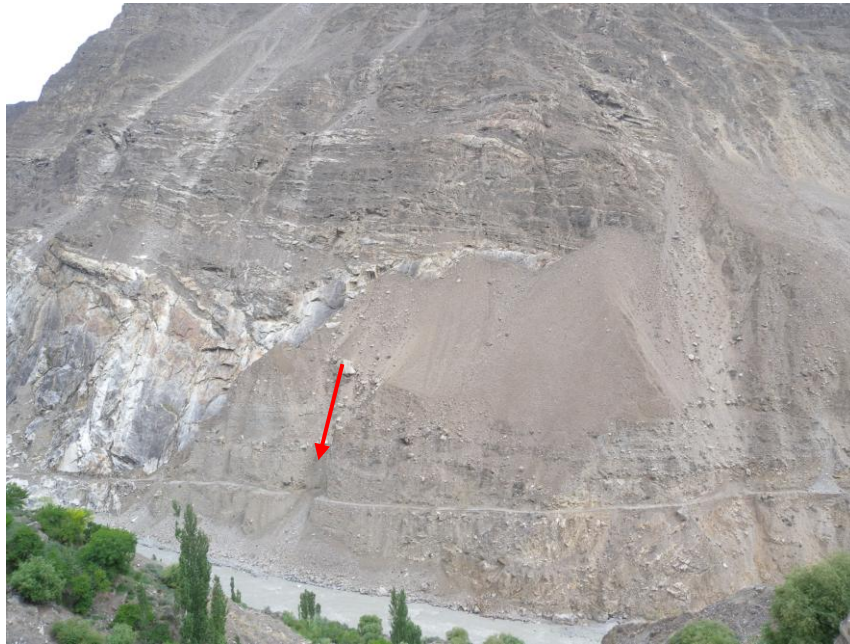
Figure 20: Old road to Nagar interrupted in several points by landslides. Red arrow indicates one of the interrupted points.

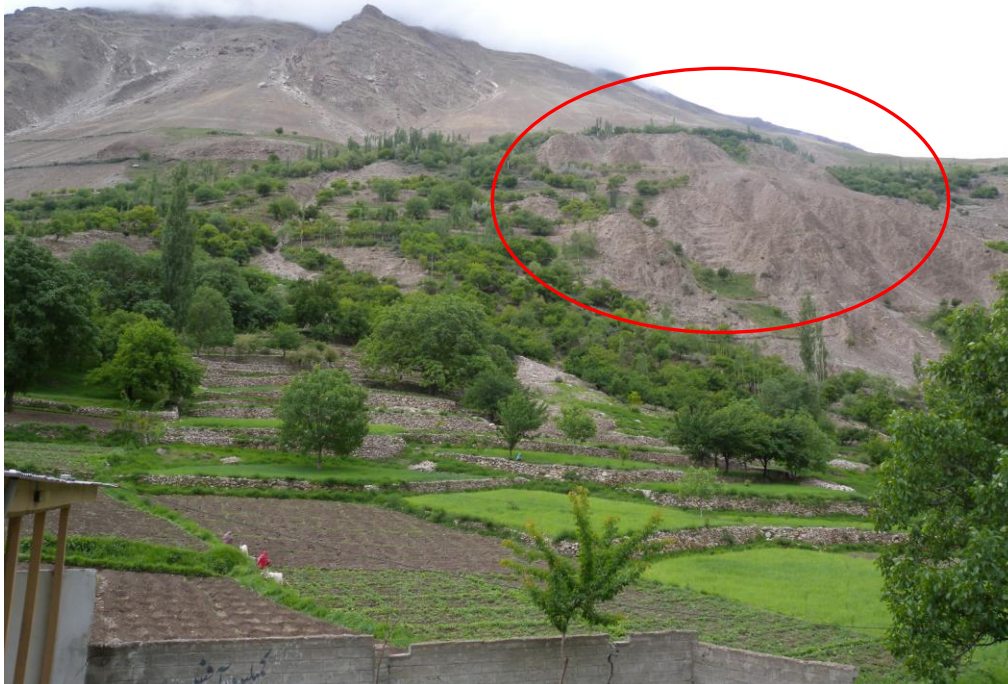
Upper Nagar village is protected from the Hunza river by a ridge of about 4400m. This situation allowed the inhabitants to build a nice and quiet village. At the end of the village, on the way to Hopar, a landslide is overhanging the cultivated fields and the houses. This landslide is in moraine material and is due to the steep slopes (Figure 21). To stabilize it, it will be necessary to reconstruct the entire slope with terraces as they are doing in Italy in the San Remo area. This will allow the cultivation of more fields and to have a better hydrogeological control of the area. Drainage will be recommended.

Figure 21: Upper Nagar landslide inside the red circle.

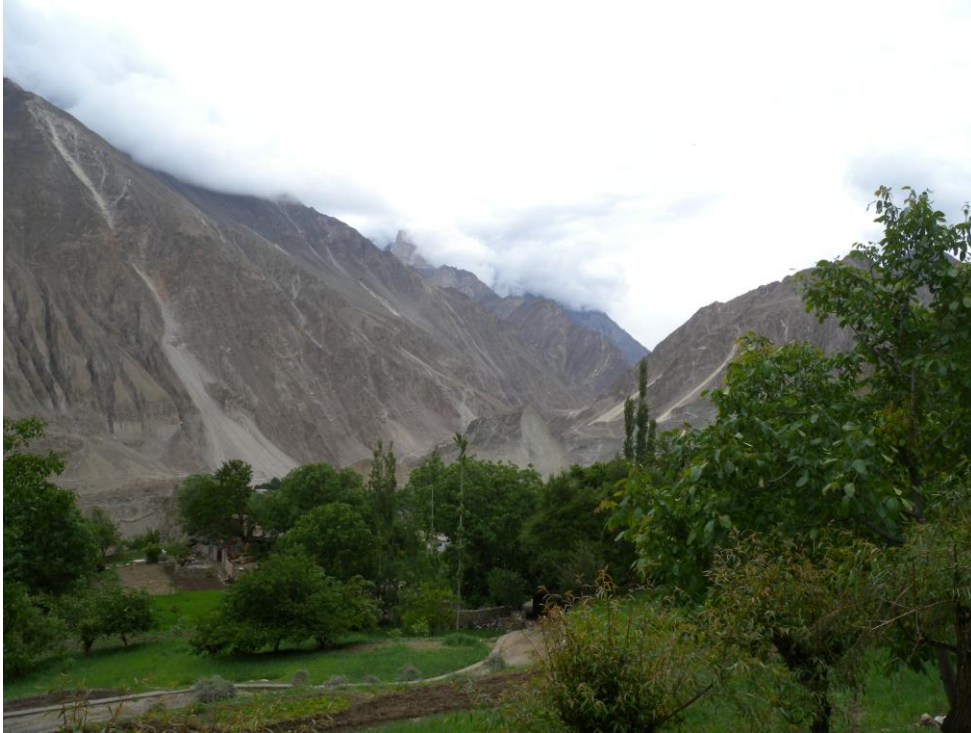
Figure 22: A landscape view of the Hepar valley; both sides of the valley are scattered with landslides. Detrital fans, due to rock falls are present everywhere and characterize the whole valley. The erosion is progressive and creates a lot of instability also along the sides of the moraines.

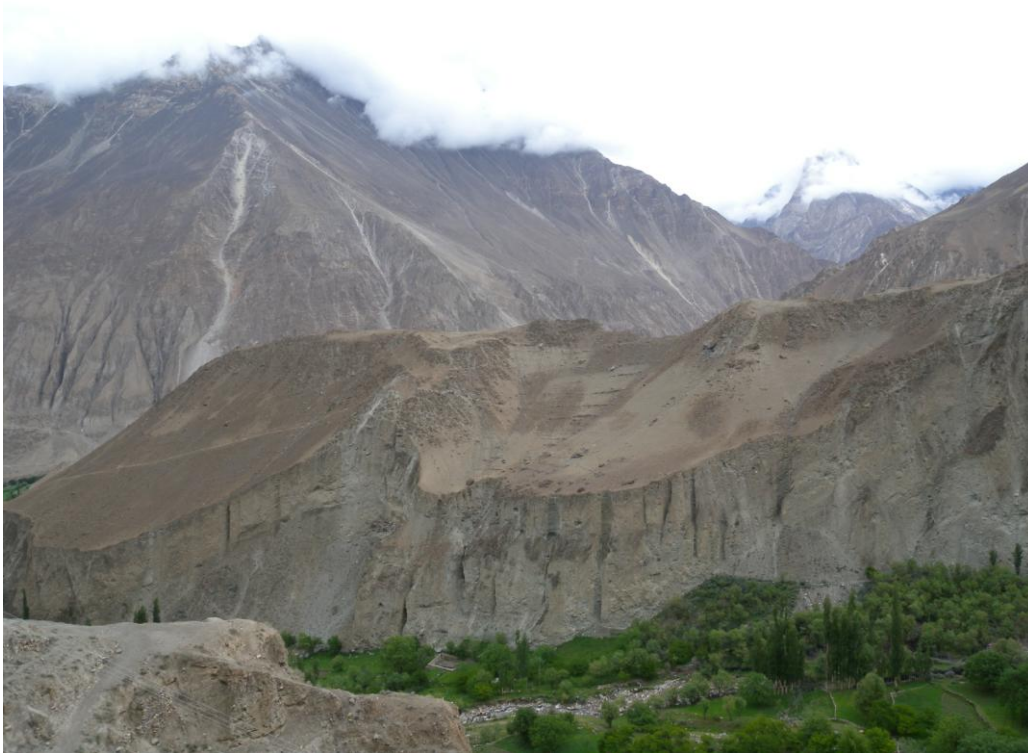
Figure 23: Erosion along moraines and alluvial terraces. The erosional process creates widespread instability. Landslides occur due to foot river erosion and from the intense runoff during monsoon rainstorms.

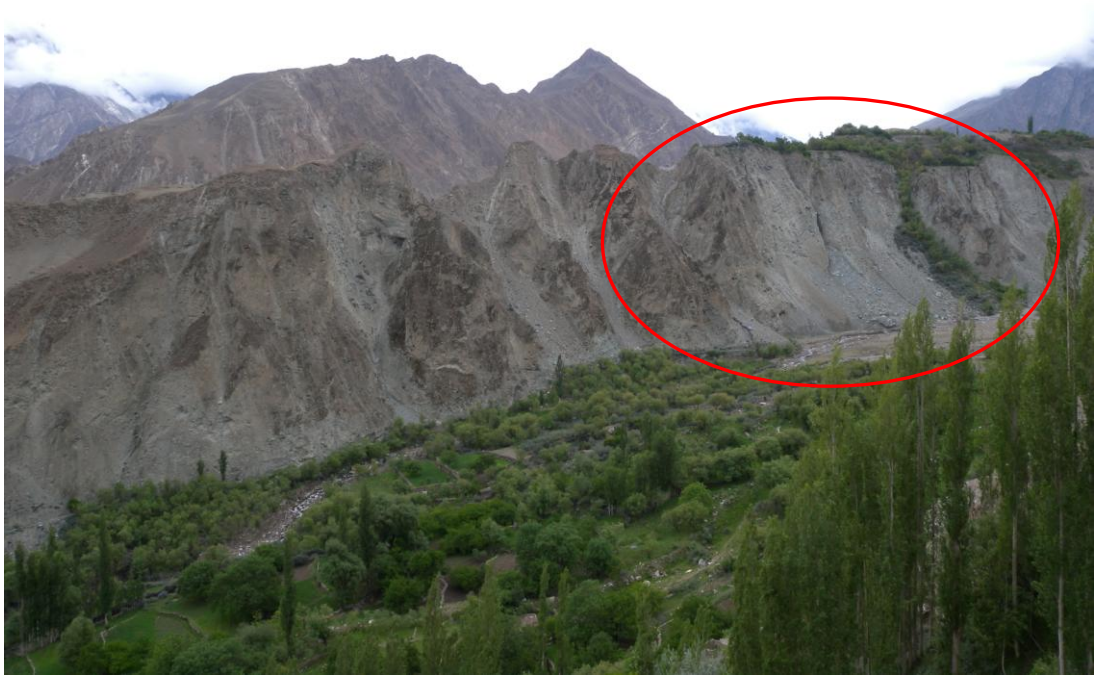
Figure 24: Landslide events.

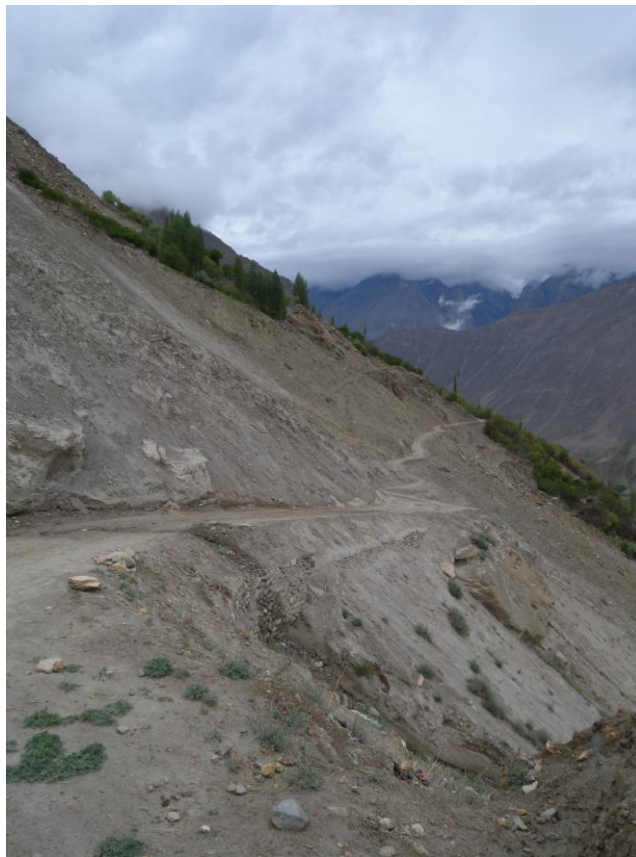
Figure 25: on the way to Holshal, a landslide with a yearly return time.

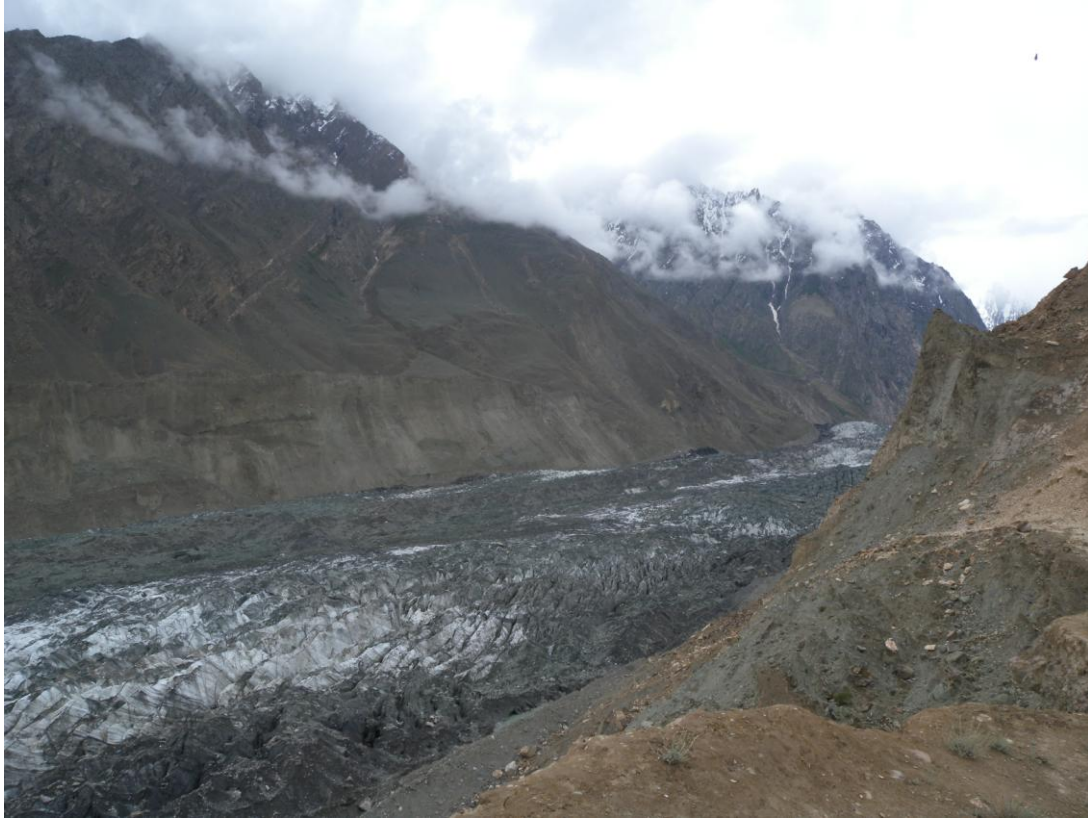
Figure 26: Hobar Glacier o Bualtar Glacier, the valley is wide and the bank sides of it are dotted by landslides an detritical fans for a width of about 350m from the glacier upper surface level. Along the slopes also during the survey, rock falls occurred. Daily glacial erosion is creating an increasing instability in the rocky sides.

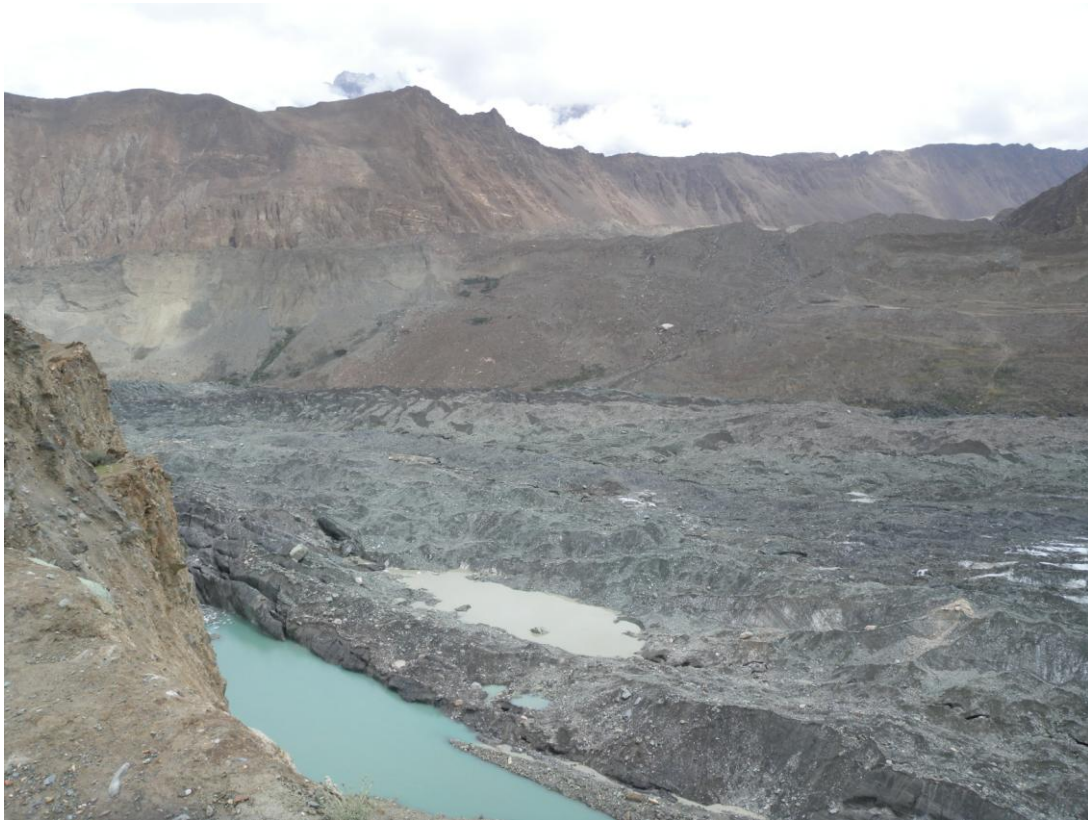
Figure 27: North view of the glacier, frontal moraine deposits are present everywhere. The glacier, during its eroding movement is creating instabilities on the sides of the valley.

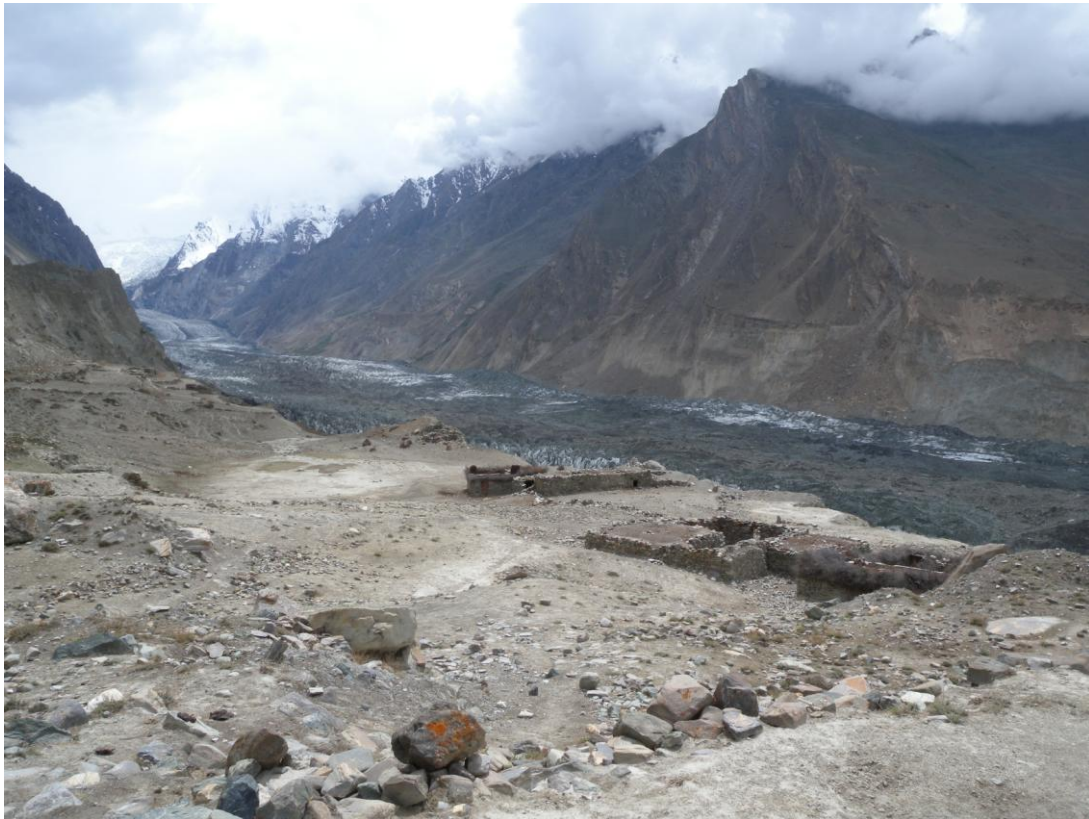
Figure 28: Panoramic view of the left side of the Hoper Glacier, at the bottom of the slope several detrital fans, indicating the evolving erosional processes are present at the bottom of the steep slopes.

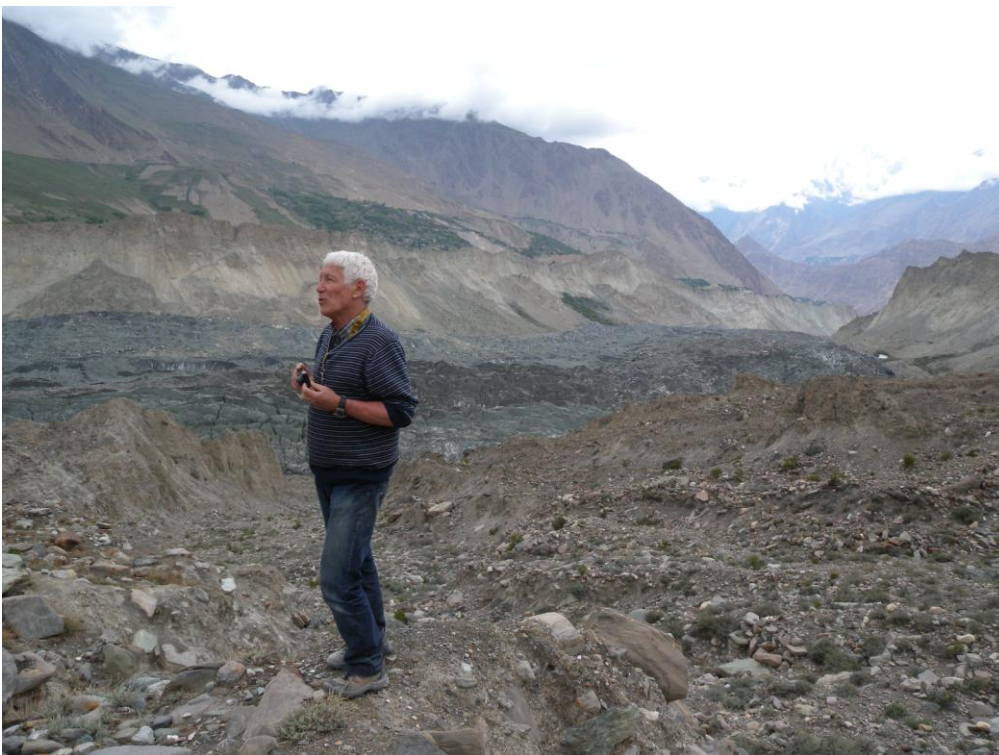
Figure 29: View of the lower part of the Hoper Glacier. In the background the eroded slopes can be seen.

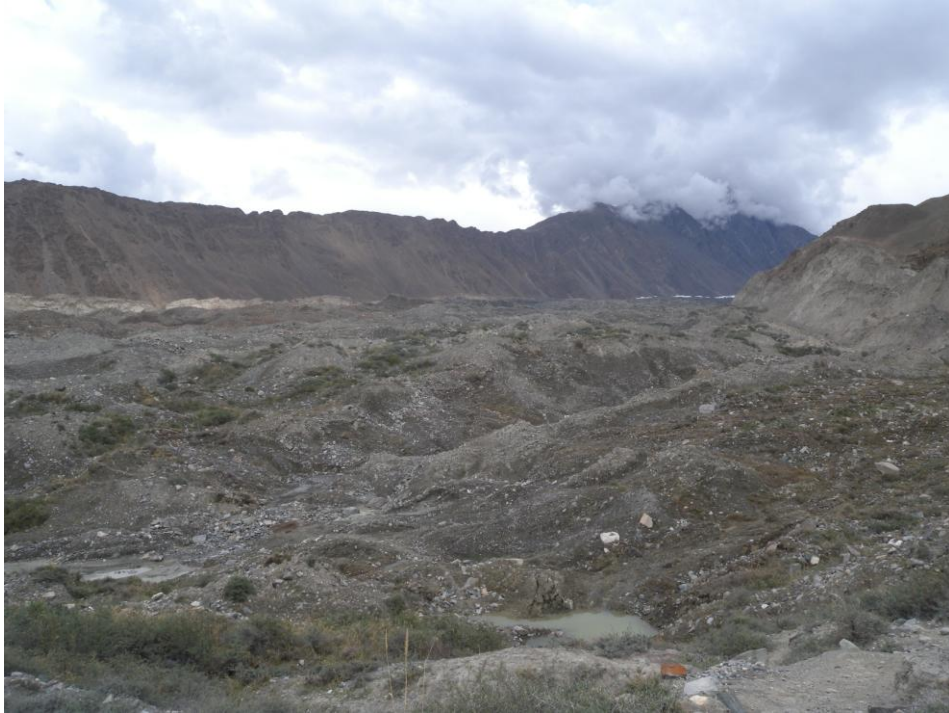
Figure 30: Barpu Glacier in the background; the moraine deposits are featured some of which are partially vegetated. As for the Hoper Glacier, the bottom part of the slope is completely eroded and the gravitational phenomena are one of the main protagonists of the landscape.

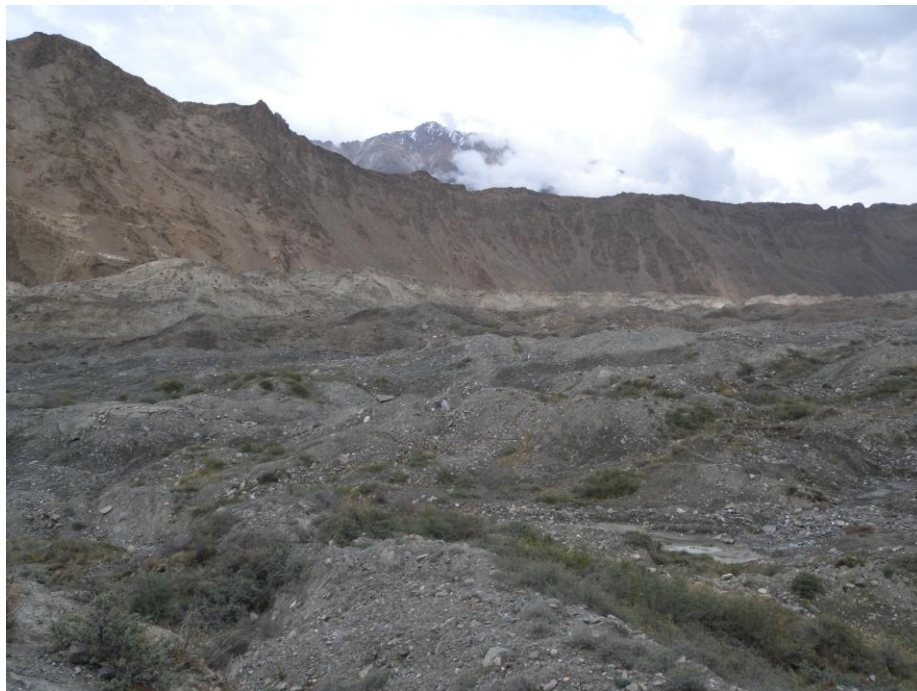
Figure 31: Frontal moraine of the Barpu Glacier.
