The Assessment of Hydrogeological and Seismic Danger in the Northern Areas and Kashmir, using GIS Techniques".

Shahina Tariq¹, Mohammad Arshad Khan², Giorgio Poretti³,

Bahria University Islamabad¹

Kashmir Earthquake

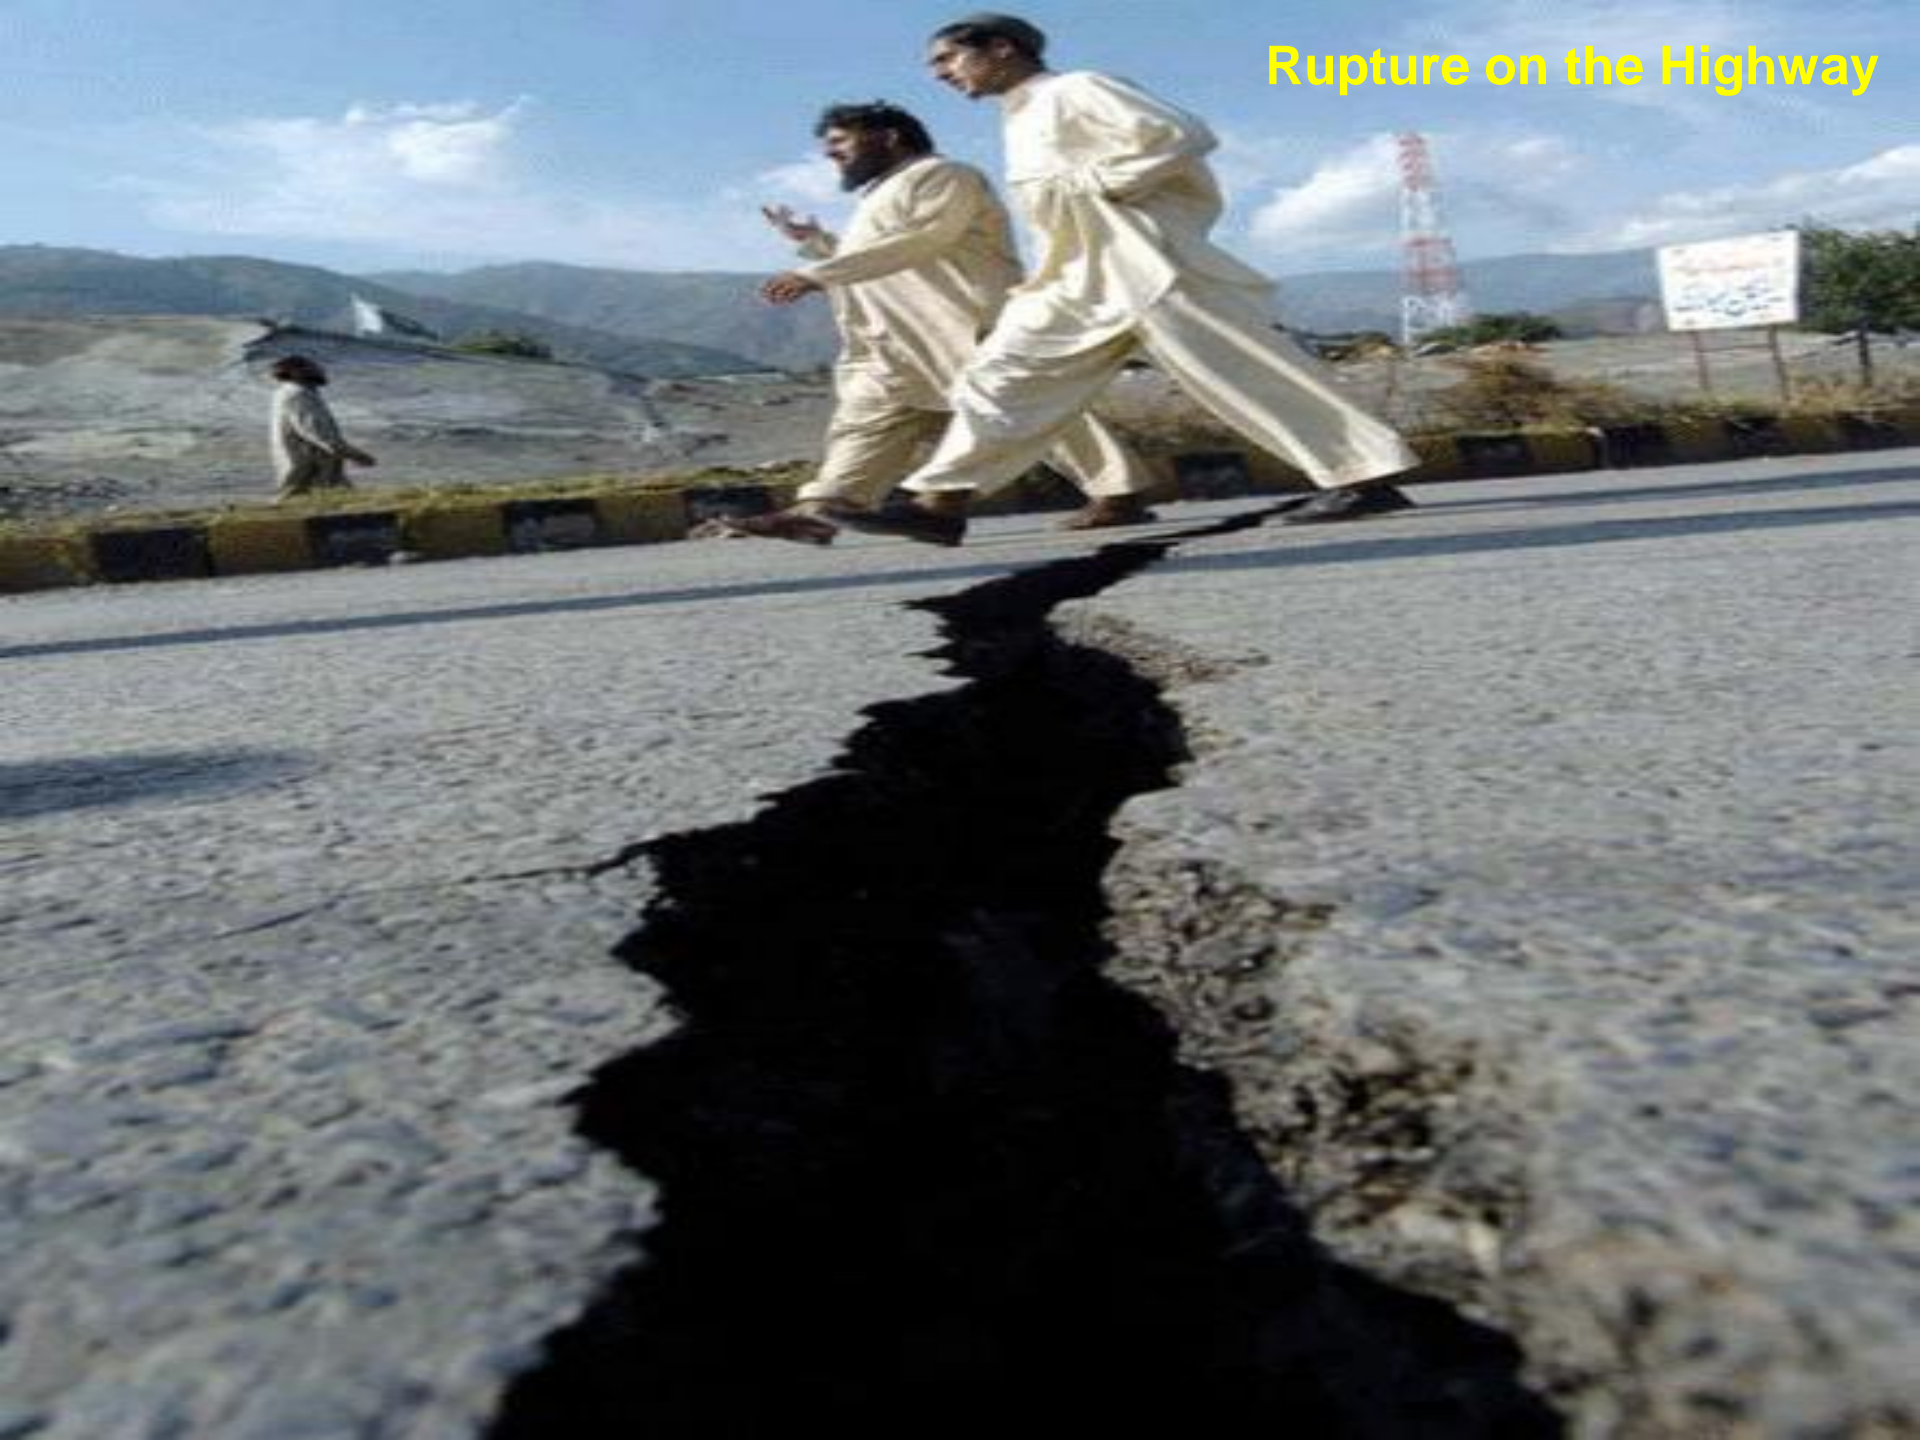
Rupture on the Highway

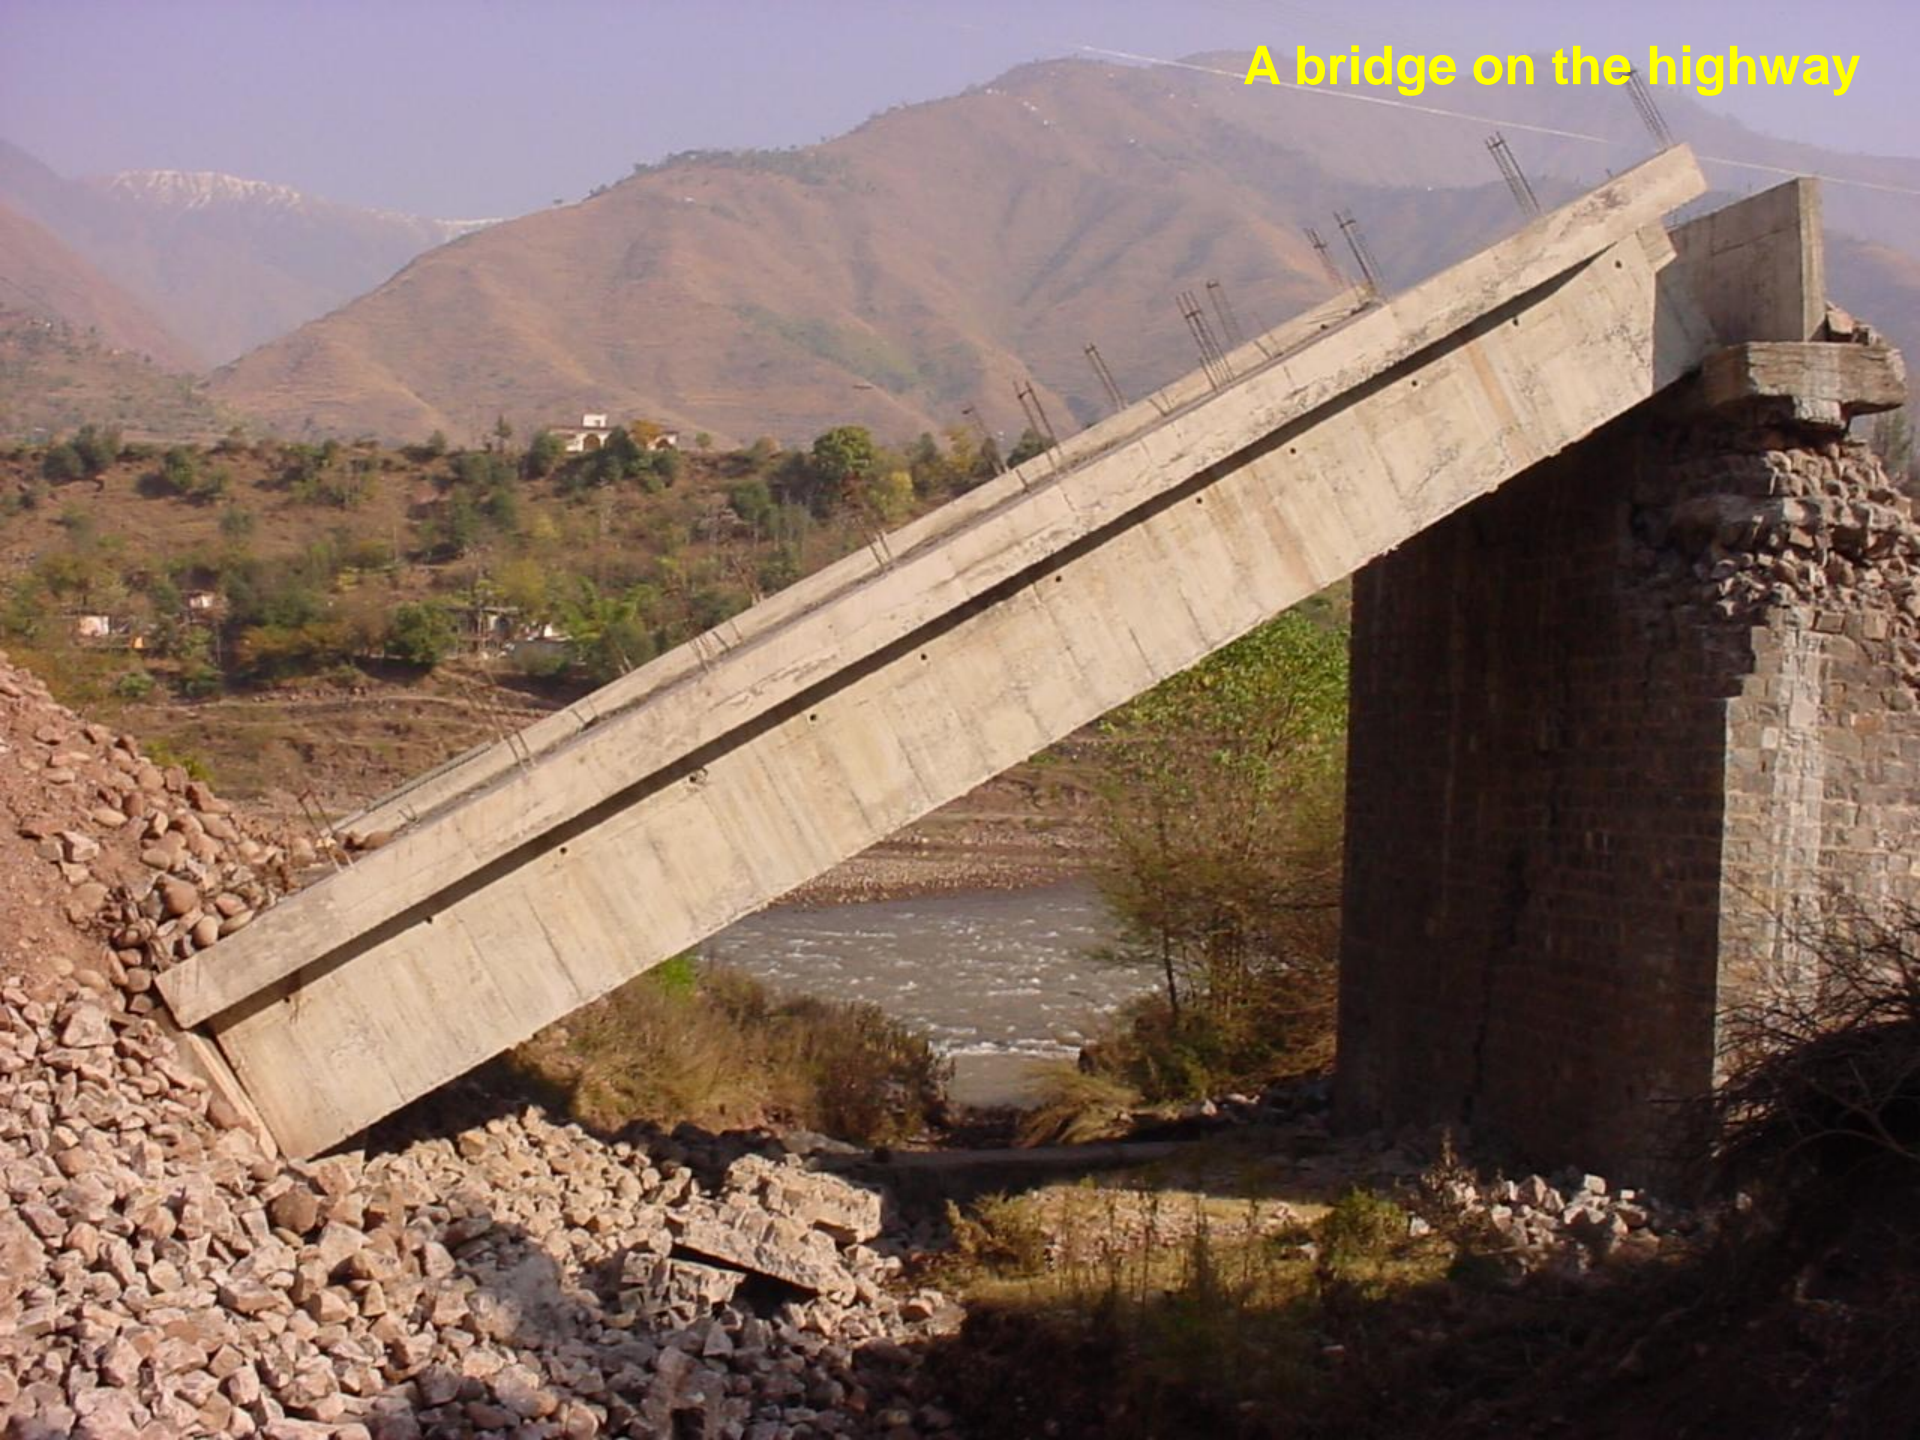
A bridge on the highway

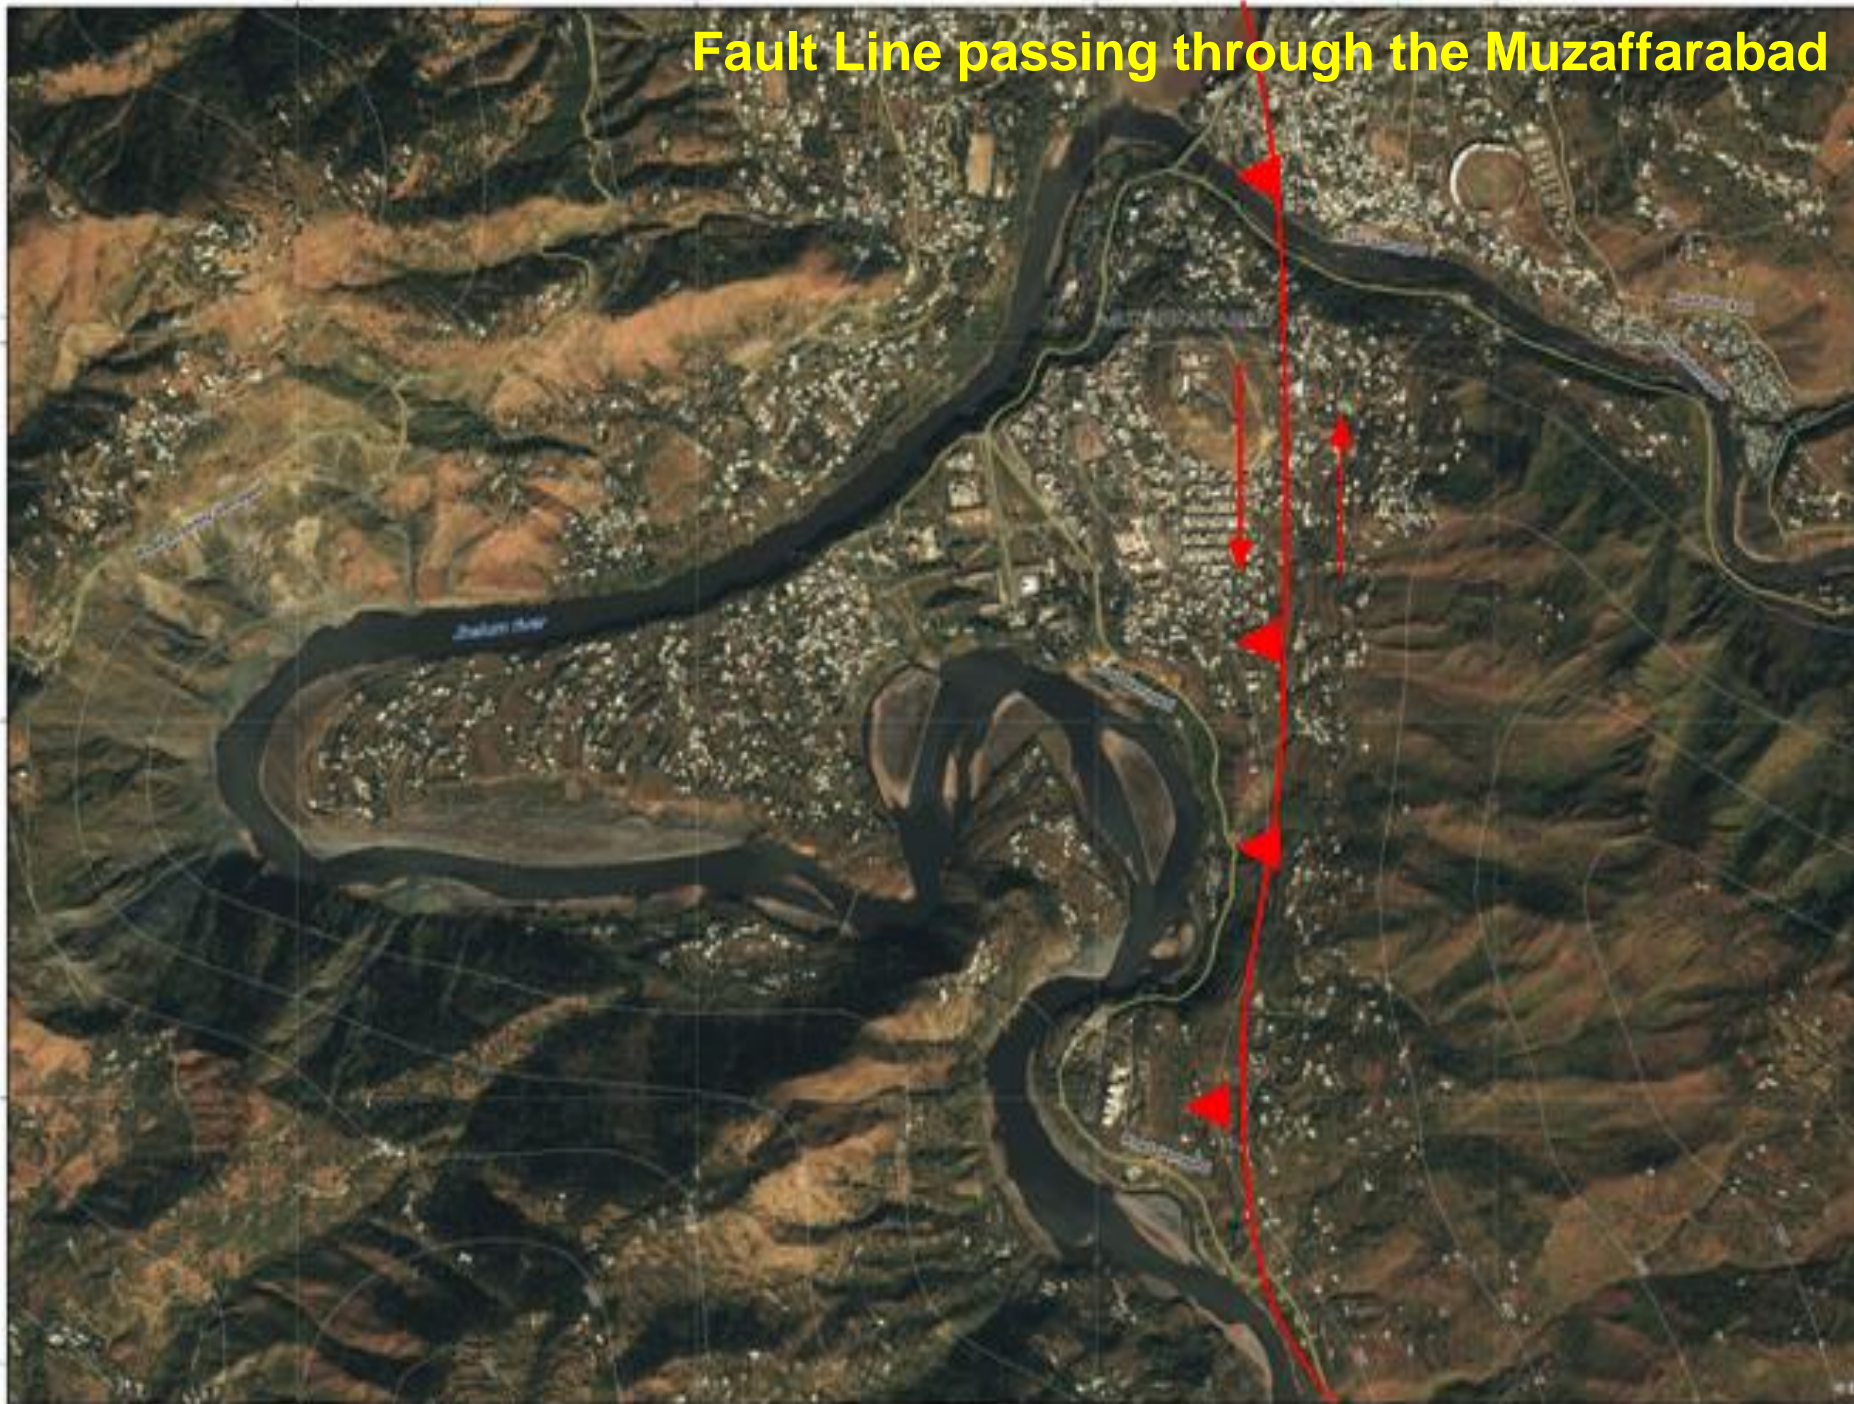
- Major faults passing through Muzaffarabad includes **Muzaffarabad fault, Jehlum fault, Punjal thrust fault, Kuai basement fault and Bagh basement fault.**
 - The earthquake area has very complex tectonic nature due to:
 - The collision of **Indian plate with Eurasian plate.**
 - A series of thrust faults and a number of basement faults exist in the area and earthquake activated these faults.

Fault Line passing through the Muzaffarabad

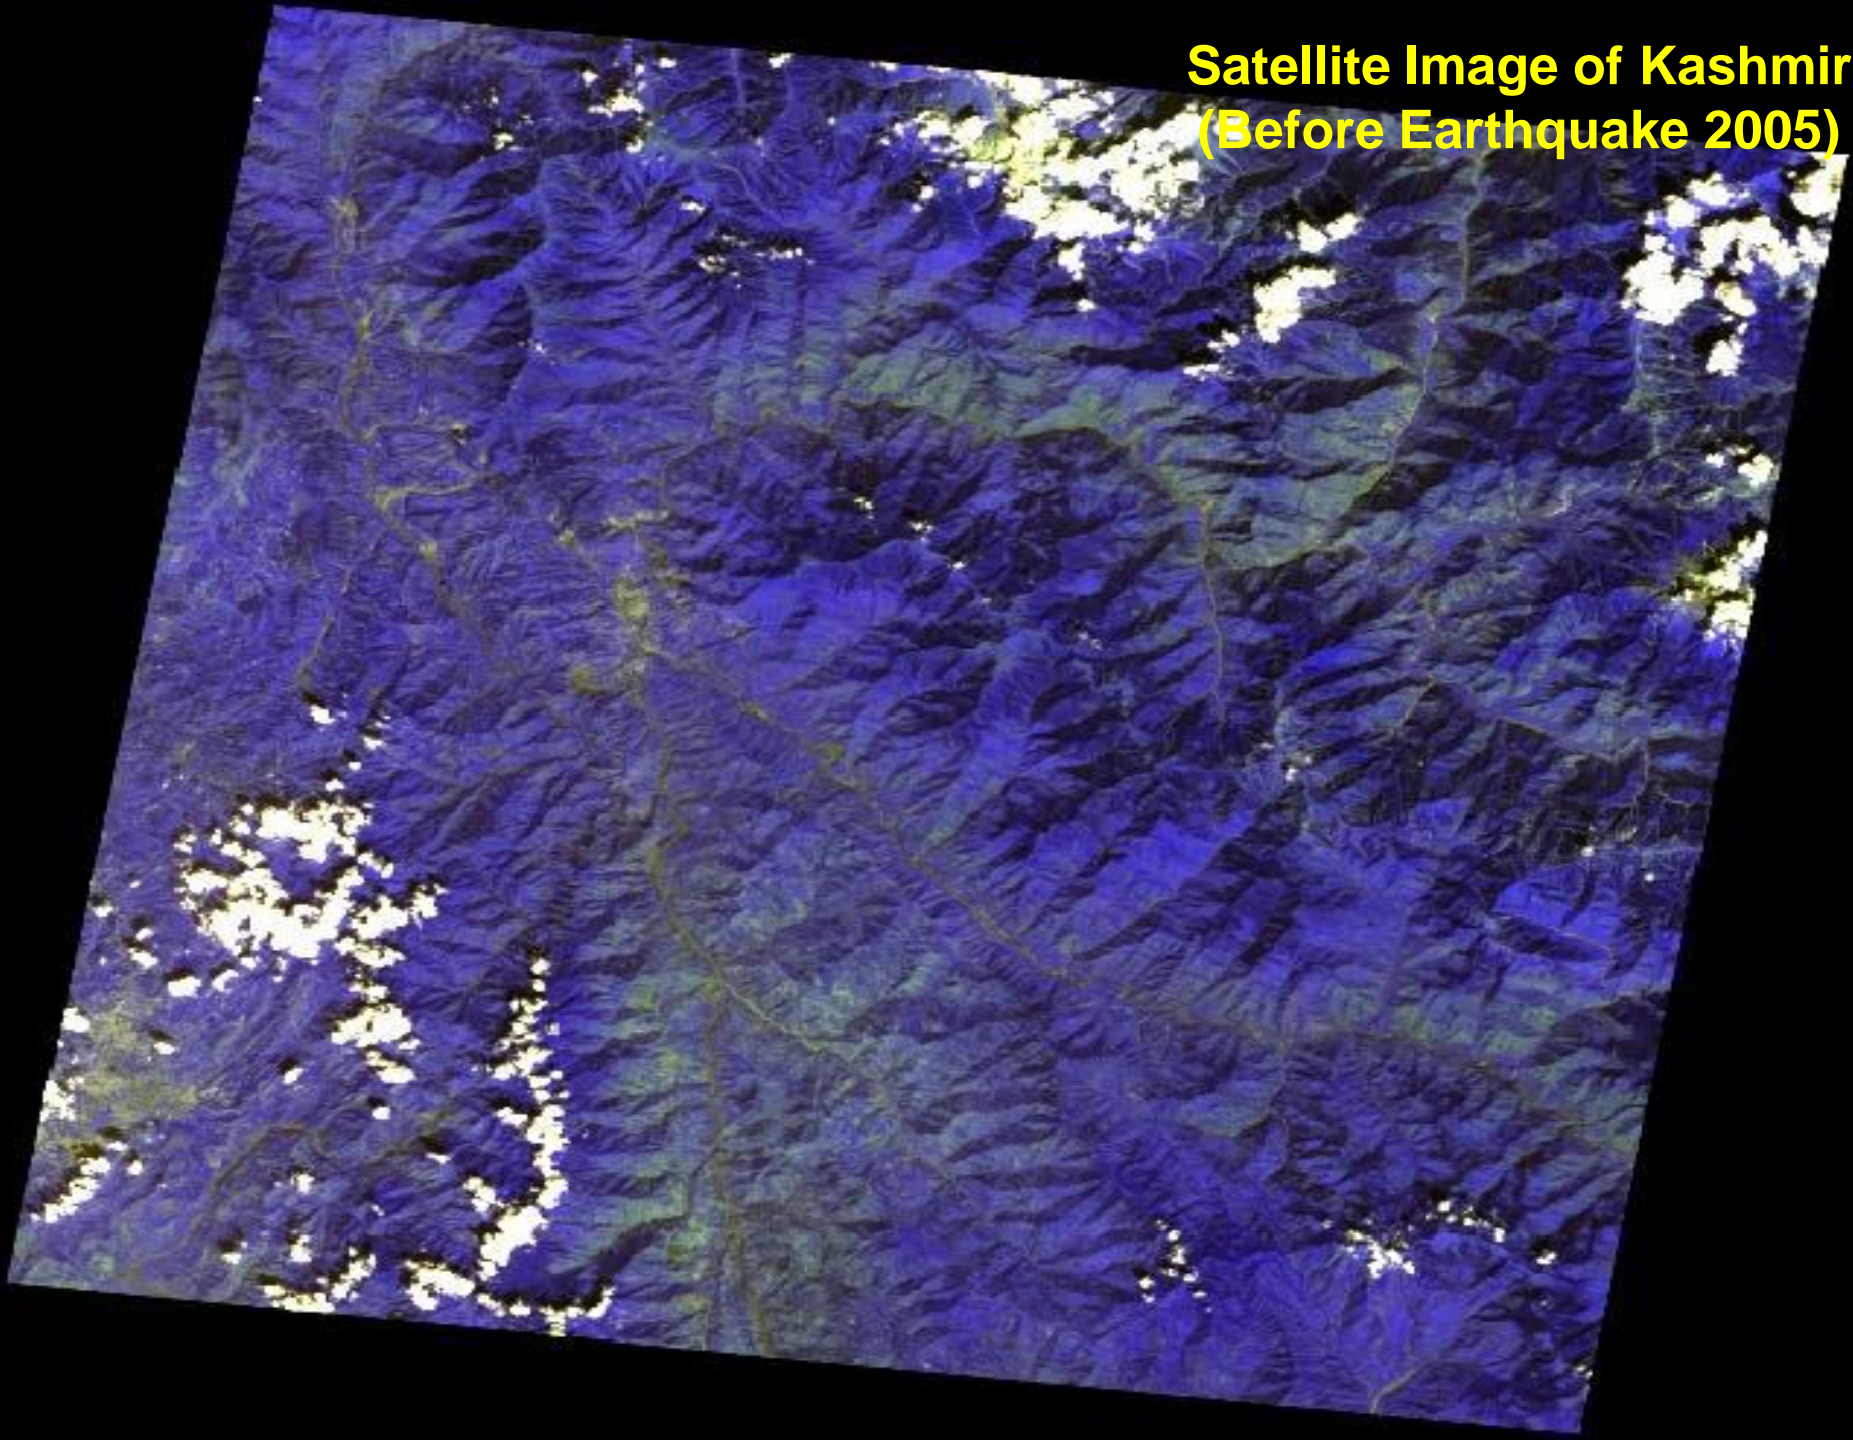
**Satellite Image of Kashmir
(Before Earthquake 2005)**

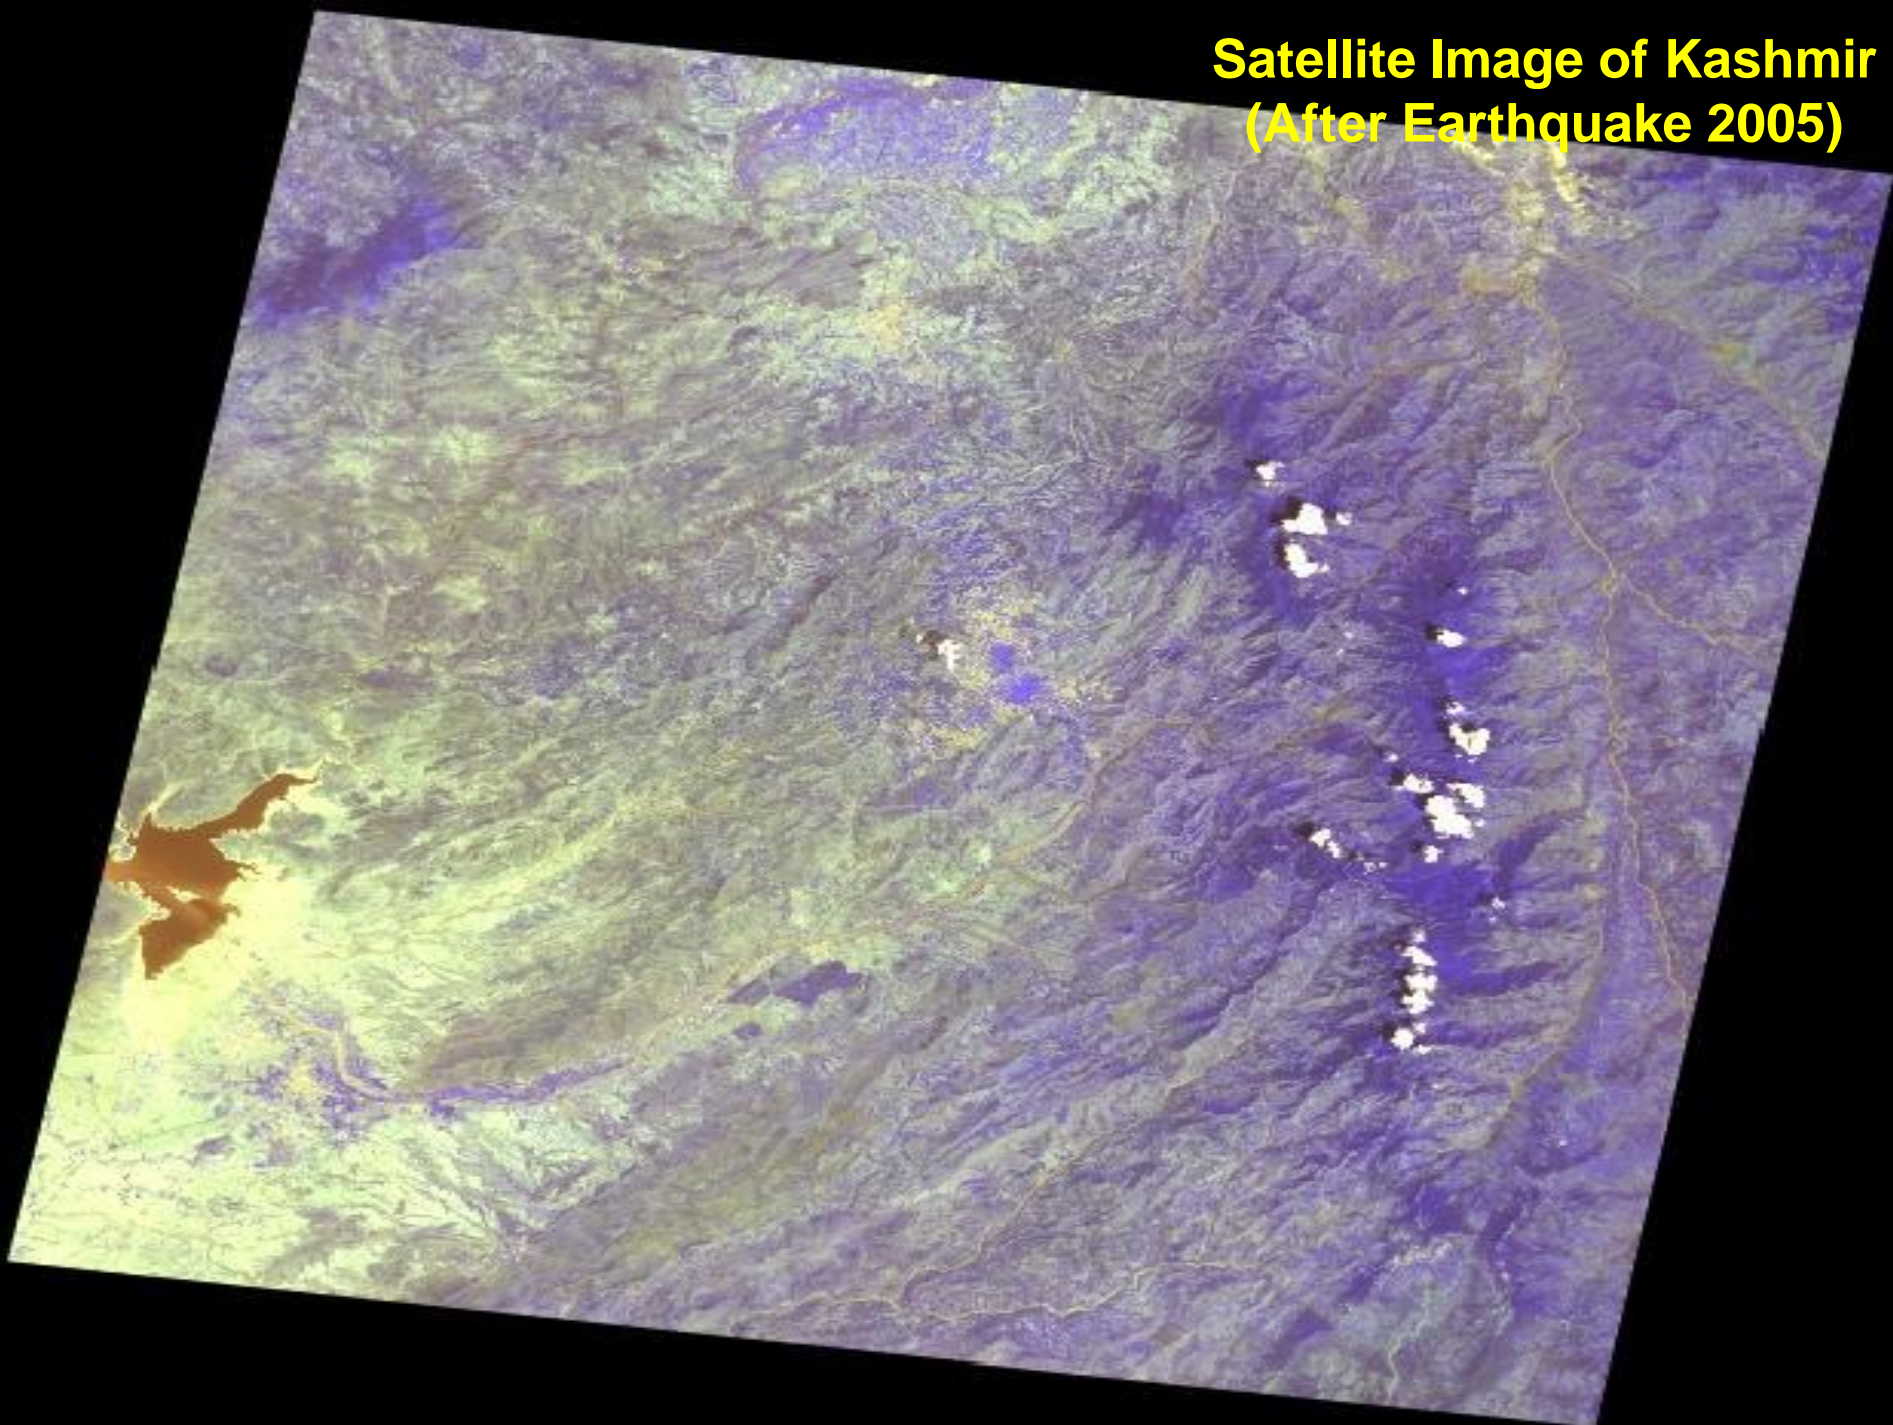
**Satellite Image of Kashmir
(After Earthquake 2005)**

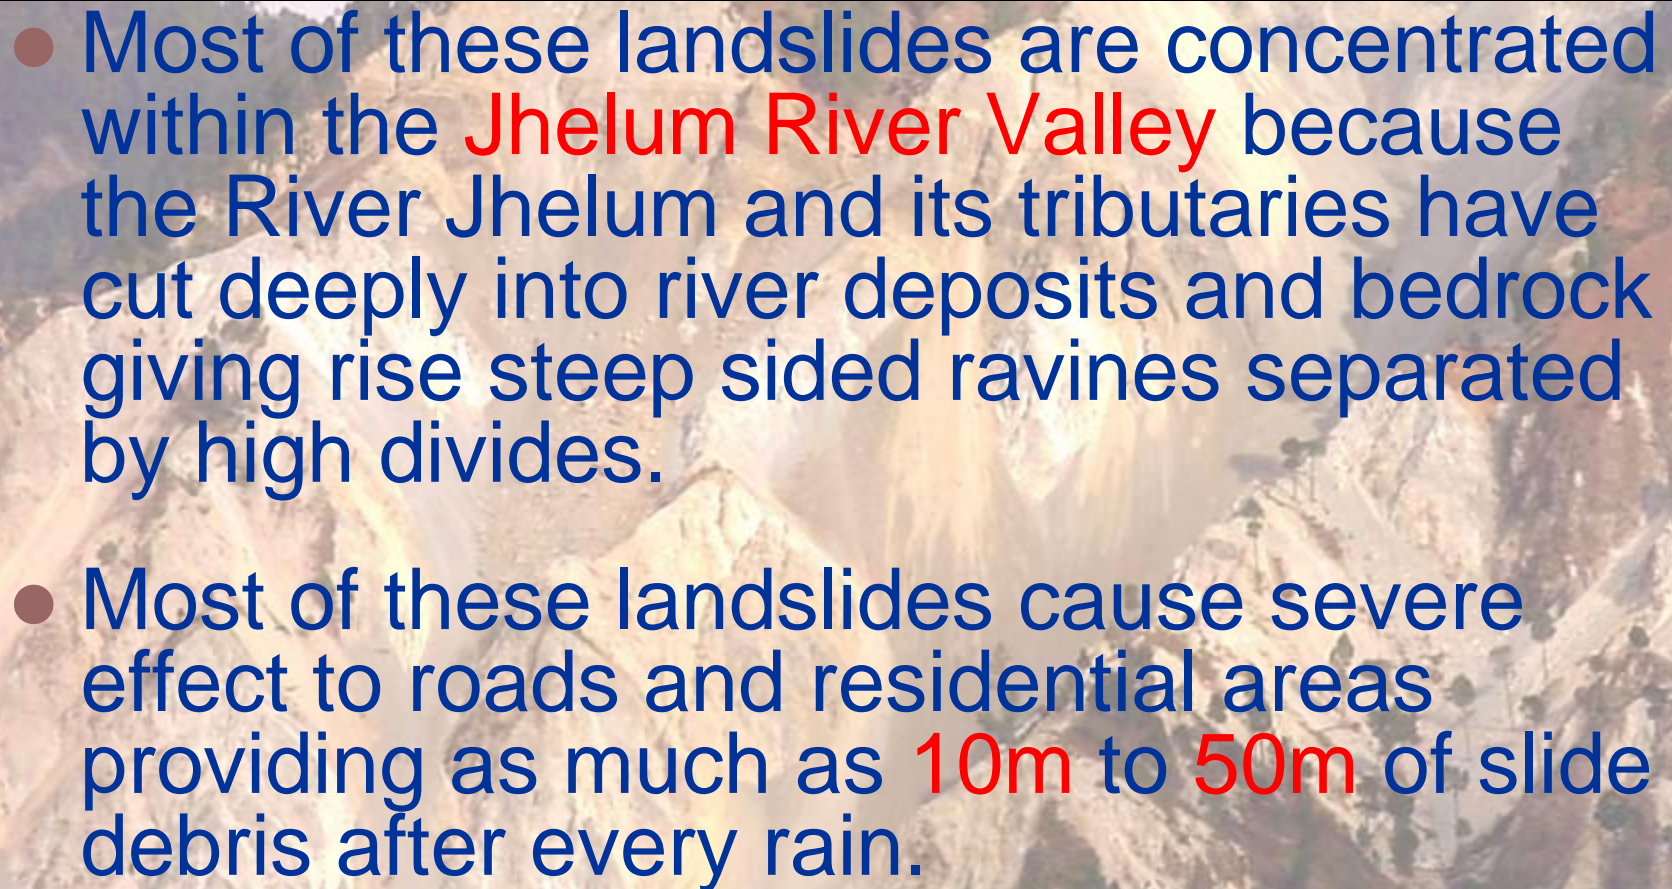
- An aerial photograph of a mountainous region, likely the Jhelum River Valley. The terrain is characterized by steep, eroded slopes with visible gullies and ravines. The river valley is prominent, showing a winding path through the landscape. The overall scene depicts a rugged and potentially landslide-prone environment.
- Most of these landslides are concentrated within the **Jhelum River Valley** because the River Jhelum and its tributaries have cut deeply into river deposits and bedrock giving rise steep sided ravines separated by high divides.
 - Most of these landslides cause severe effect to roads and residential areas providing as much as **10m to 50m** of slide debris after every rain.

Most of the landslide hazards were found in **Murree formation** in the MBT zone. This zone mainly consists of reddish brown Murree clays, highly fractured Murree sandstones, silty and sandy clays and claystones.

On top of it, **earthquake** of 08 October 2005 and subsequent **heavy rainfall** triggered so many landslides in the area.

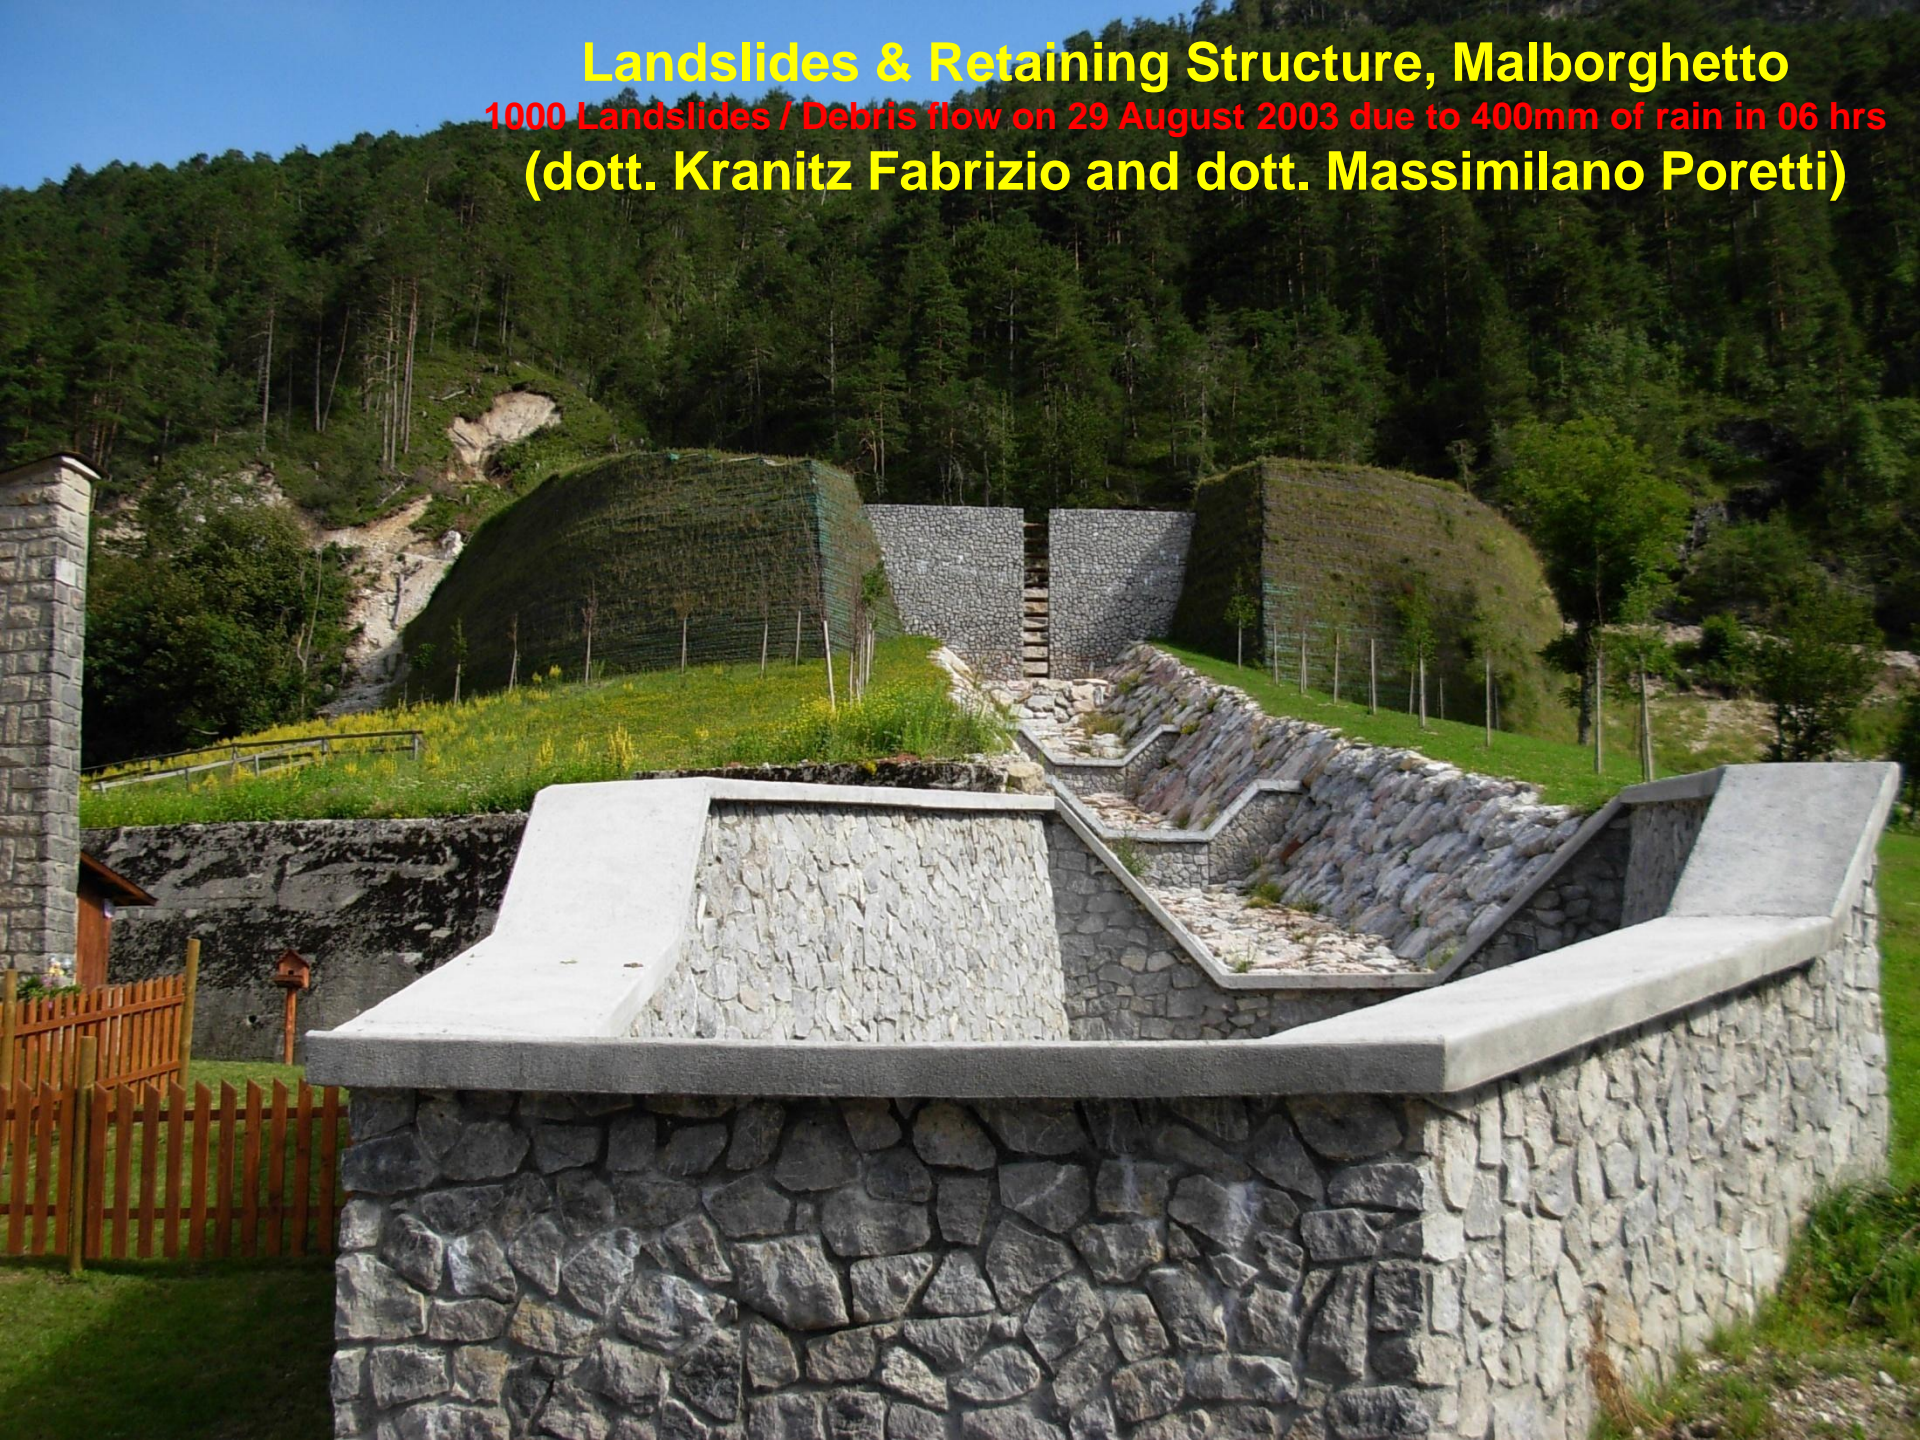
Landslides & Retaining Structure, Malborghetto
1000 Landslides / Debris flow on 29 August 2003 due to 400mm of rain in 06 hrs
(dott. Kranitz Fabrizio and dott. Massimilano Poretti)

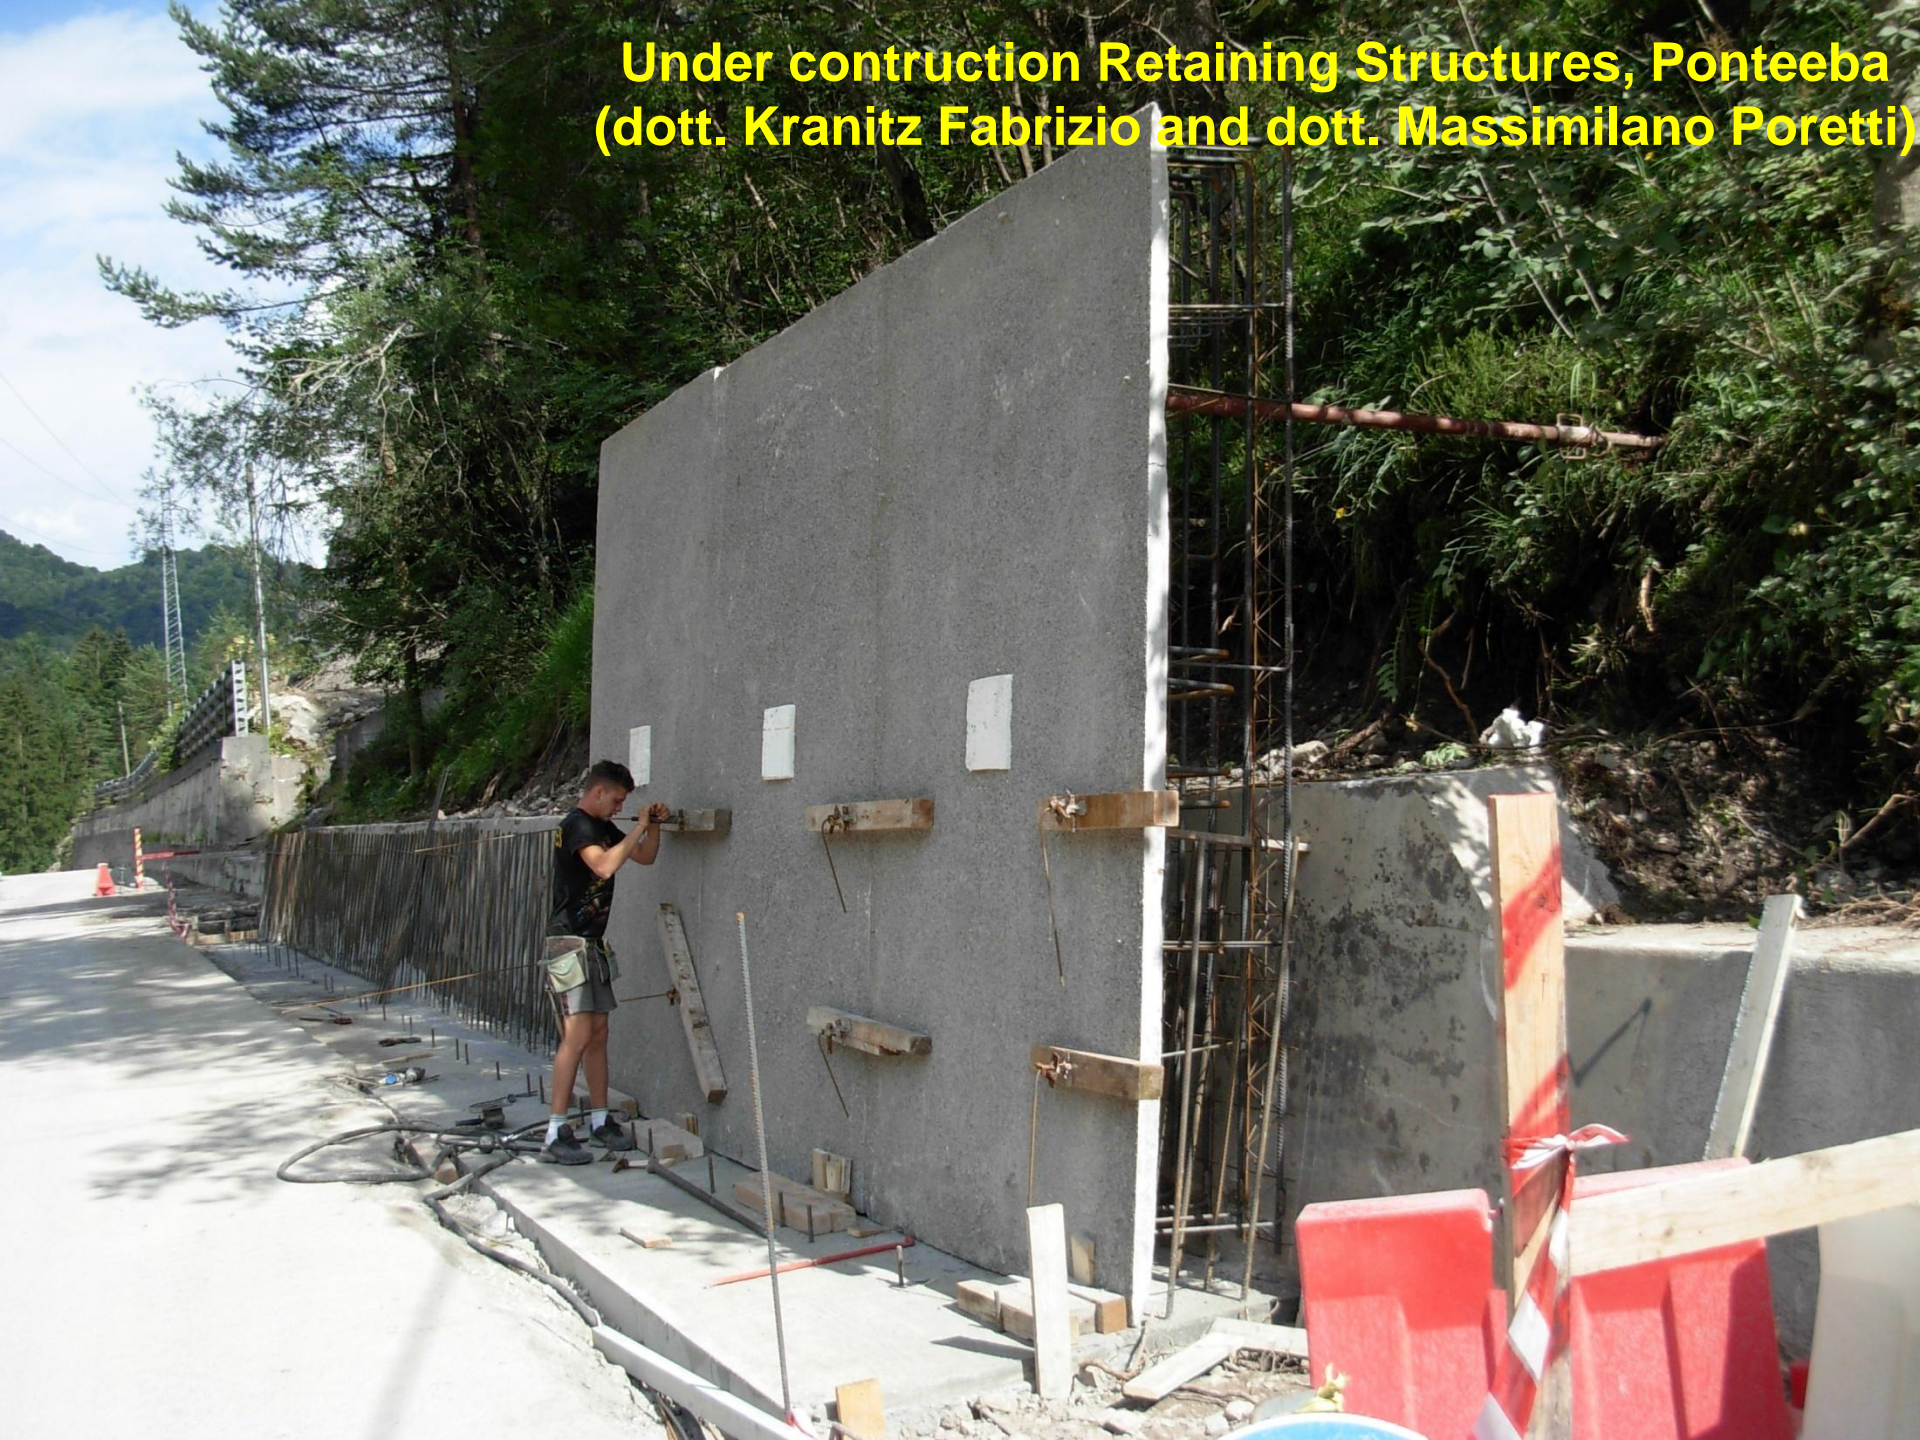
**Under construction Retaining Structures, Ponteeba
(dott. Kranitz Fabrizio and dott. Massimilano Poretti)**
