The Assessment of Hydrogeological and Seismic Danger in the Northern Areas and Kashmir, using GIS Techniques".

Shahina Tariq¹, Mohammad Arshad Khan², Giorgio Poretti³,

Bahria University Islamabad¹

Kashmir Earthquake

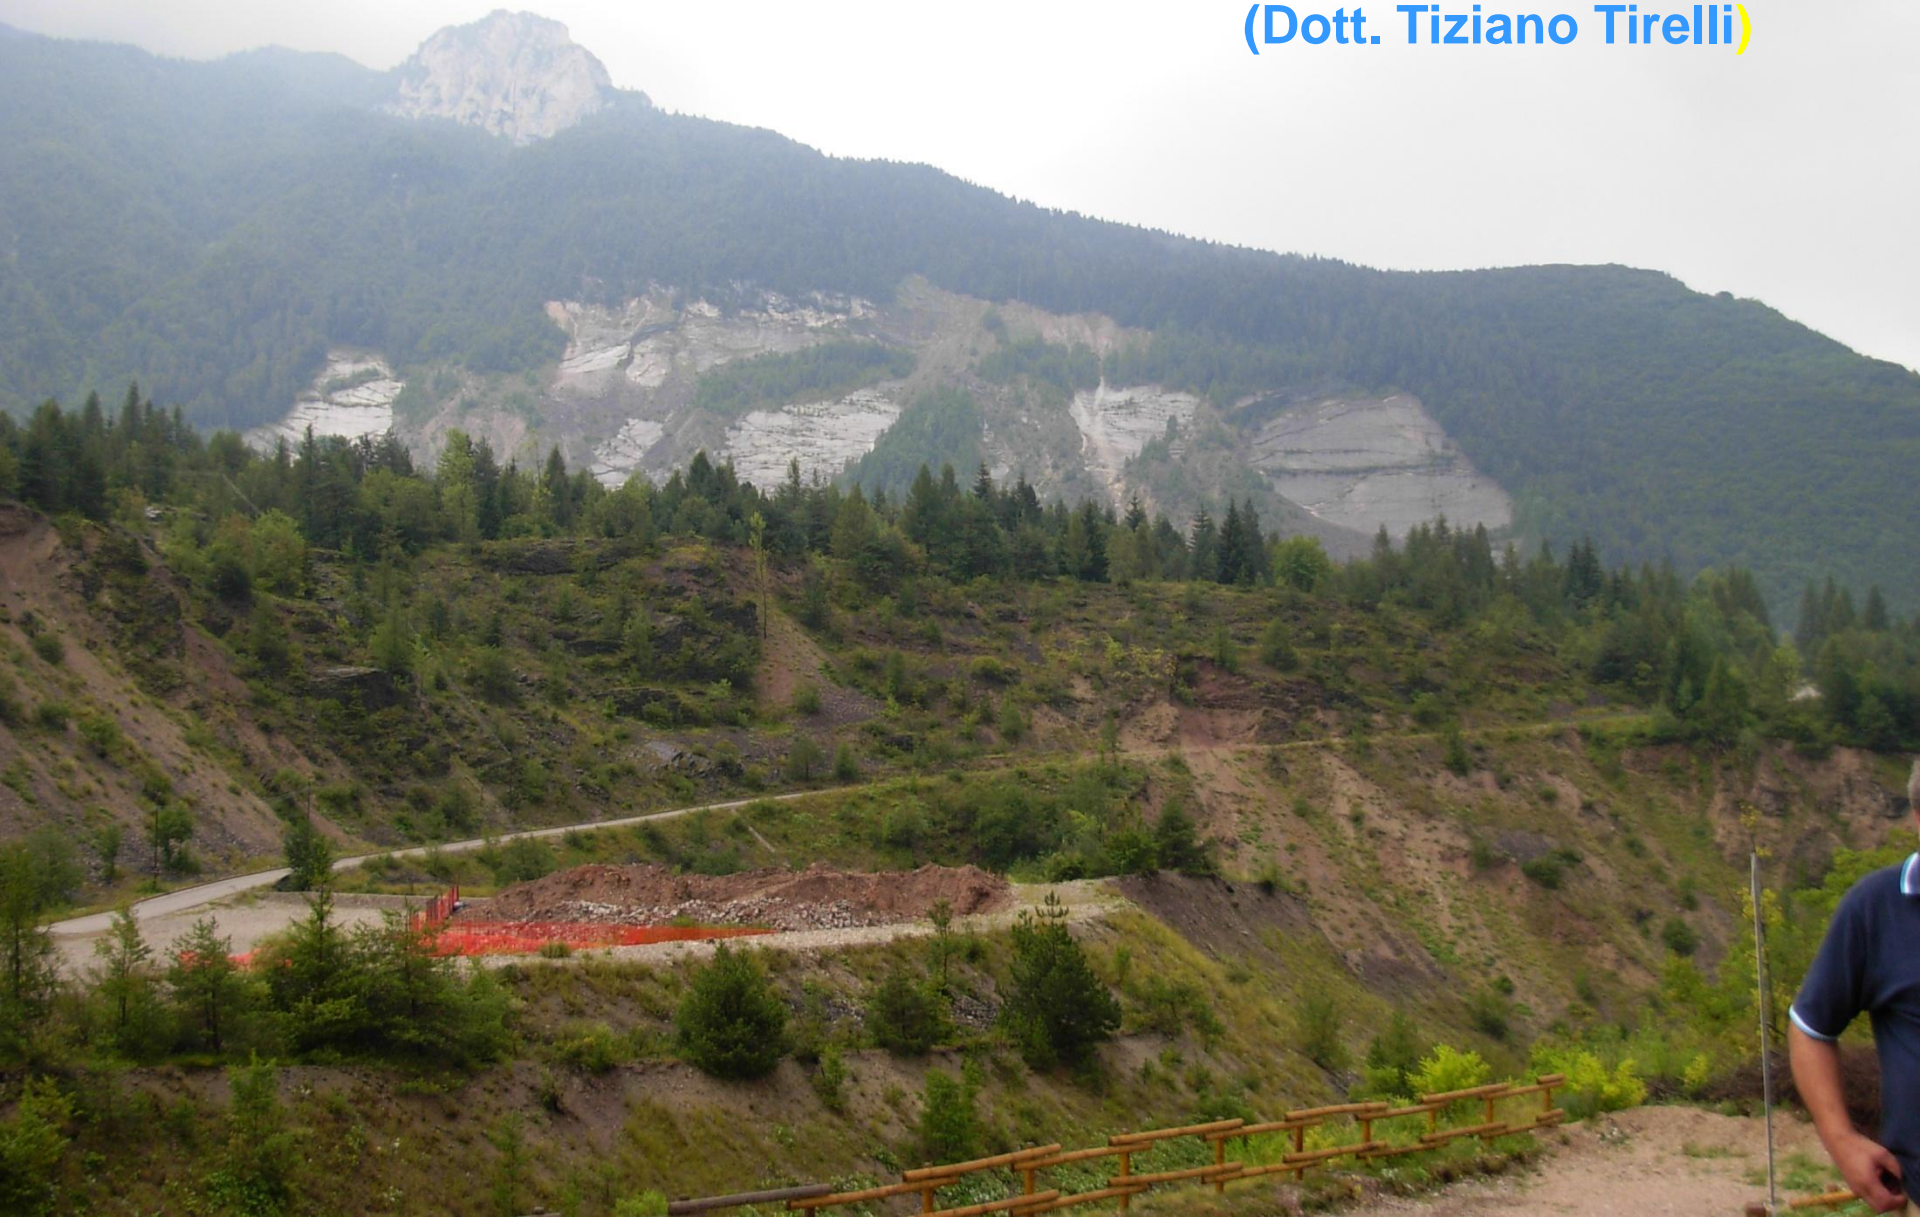
Landslide at CASSO

09 October, 1963: 2000 Deaths

90 Km/min: 250 Million m³ Debris

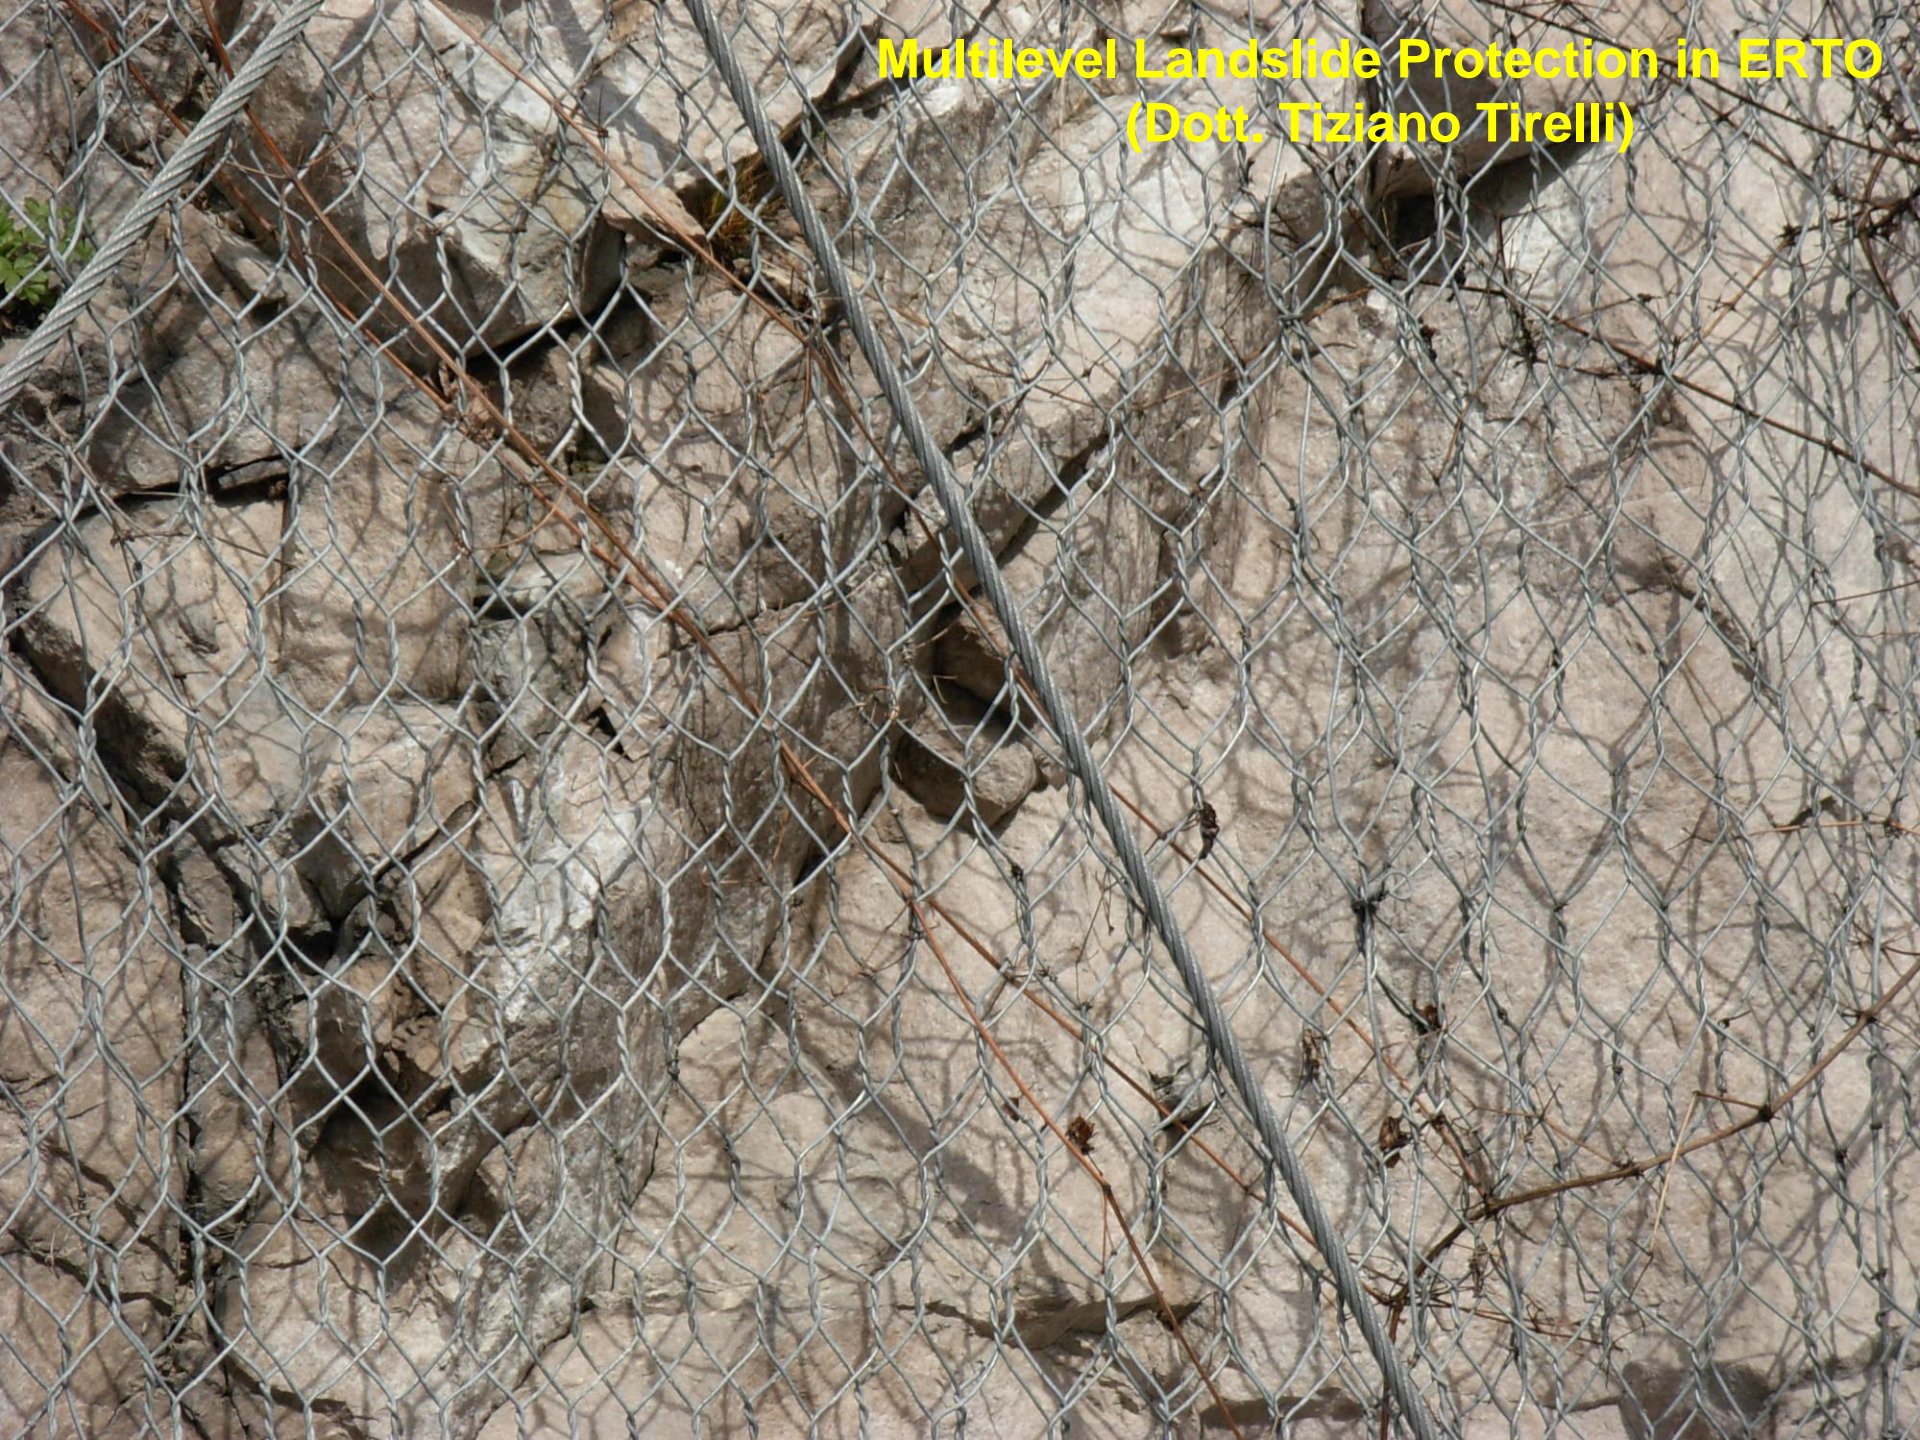
**Multilevel Landslide Protection in ERTO
(Dott. Tiziano Tirelli)**

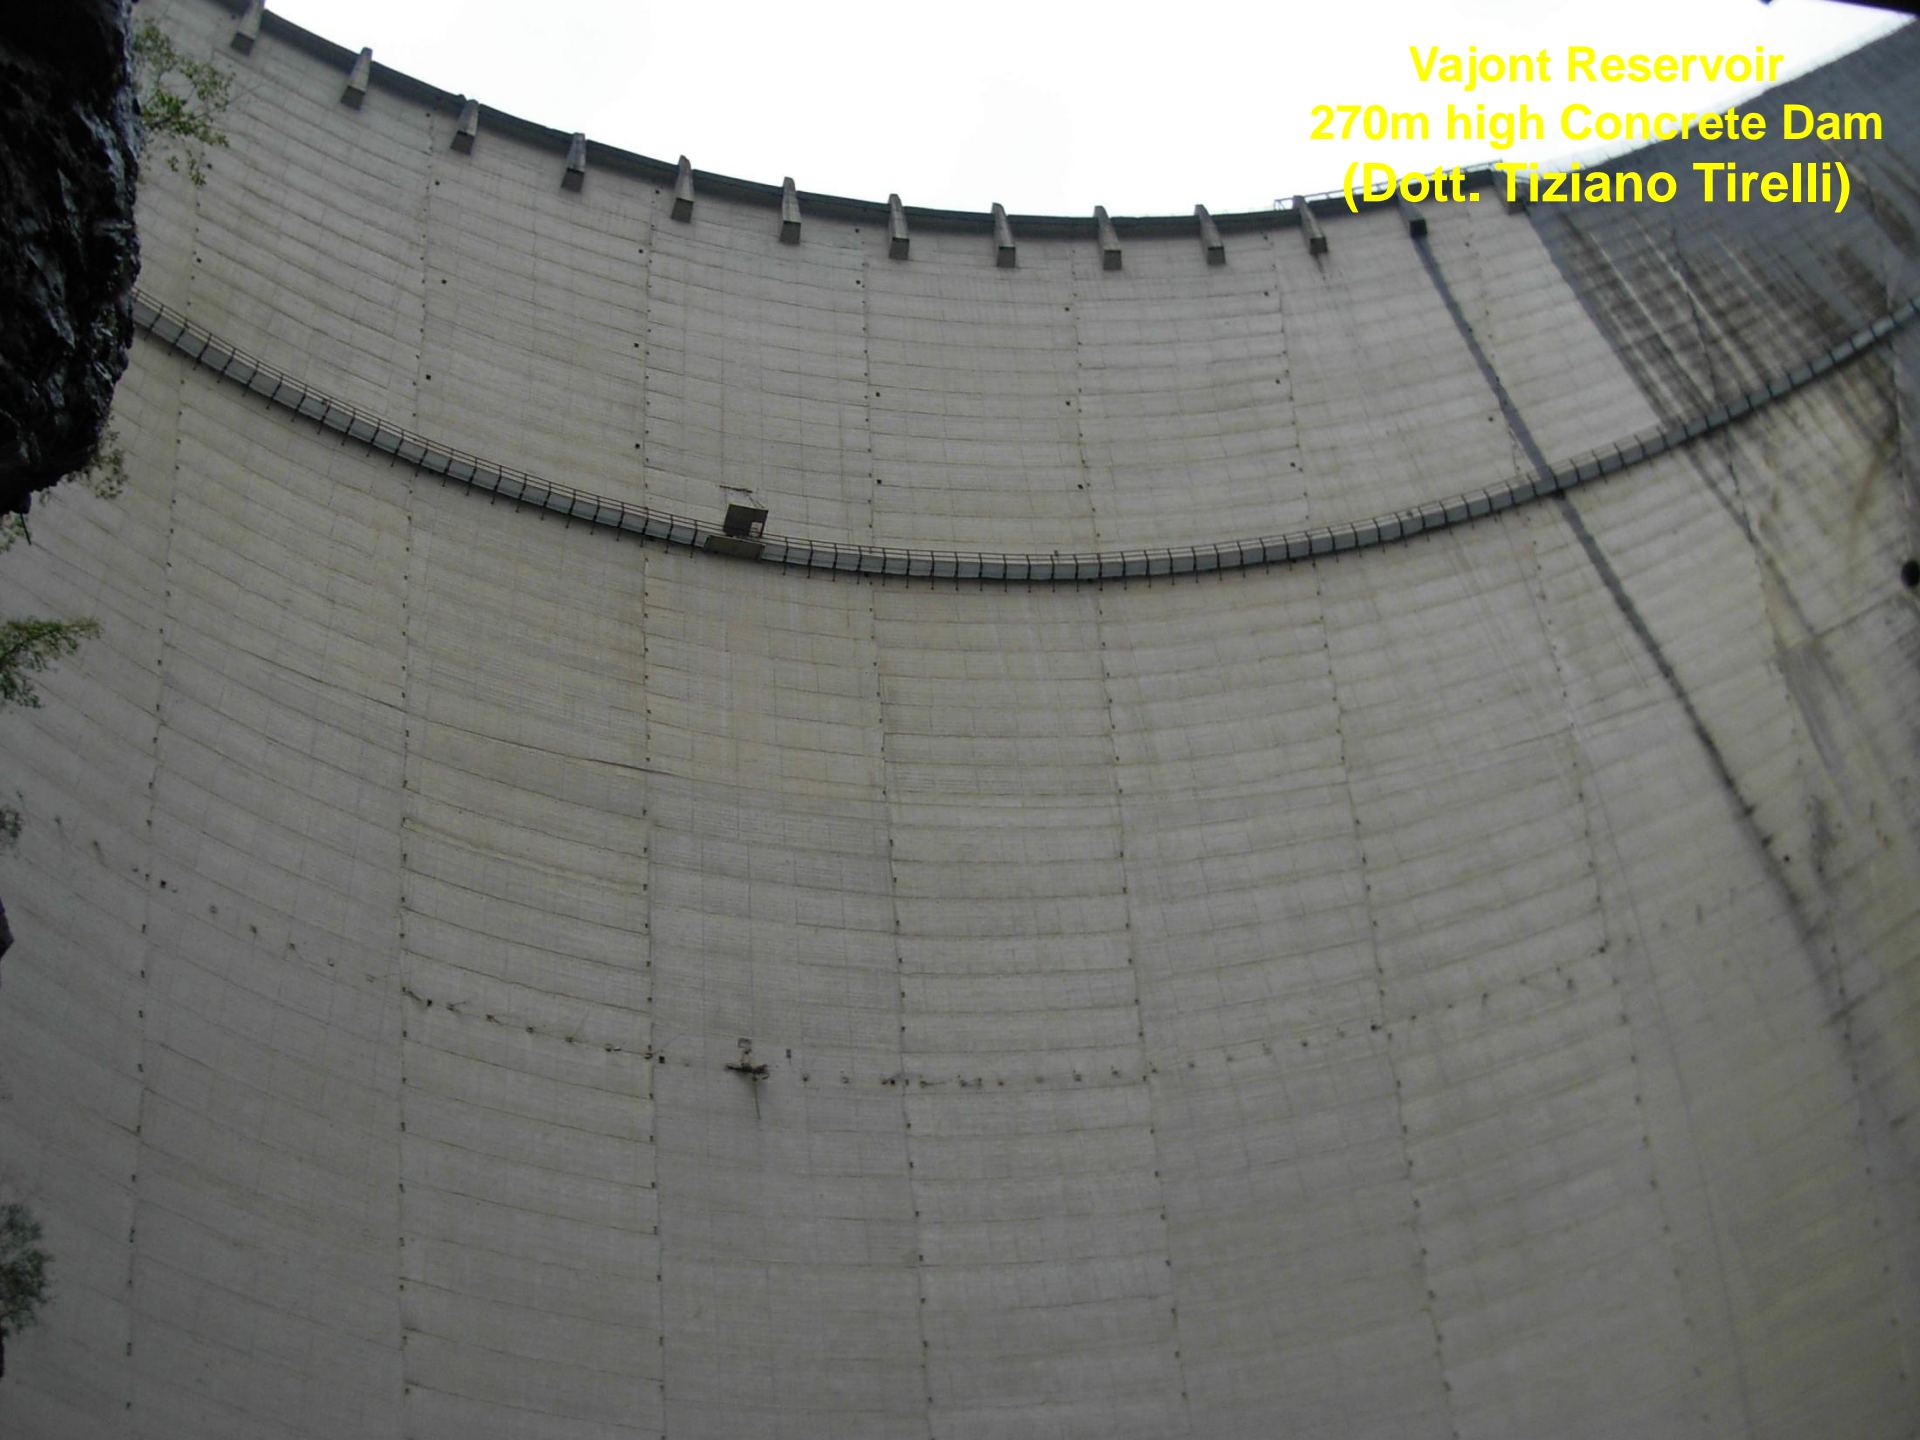
**Vajont Reservoir
270m high Concrete Dam
(Dott. Tiziano Tirelli)**

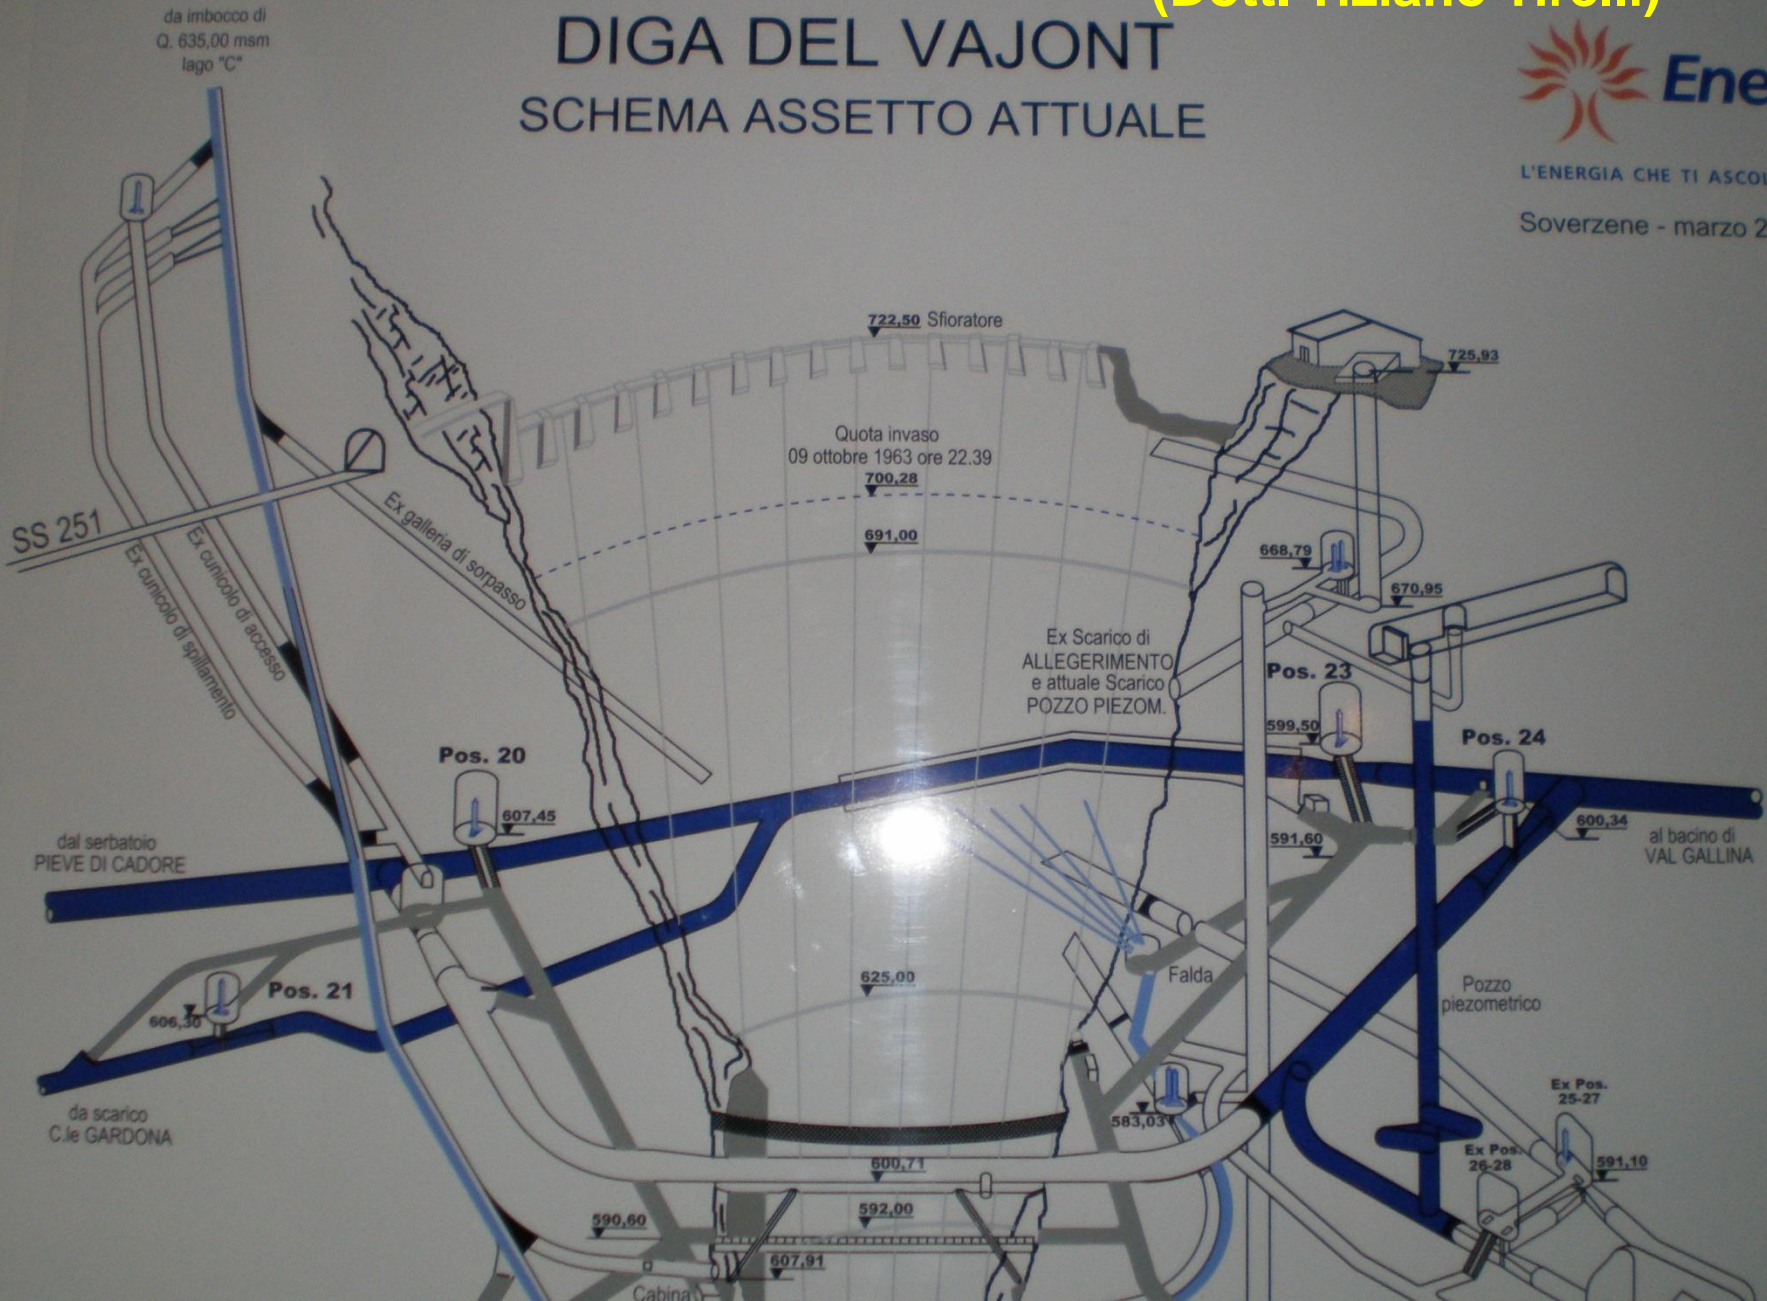
Technical Specs of Vajont Reservoir (Dott. Tiziano Tirelli)

DIGA DEL VAJONT SCHEMA ASSETTO ATTUALE
